the **play inspection** company

Annual Inspection

High Street Recreation Ground

Inspection Ref: 1294386

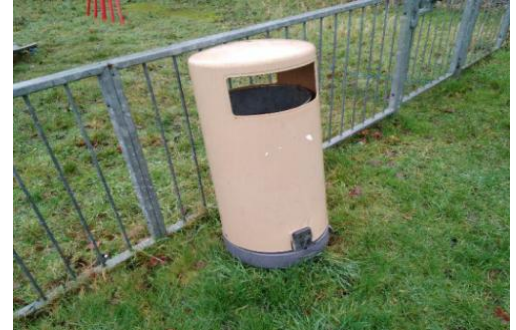
Item: Litter Bin
Manufacturer: Owner/Operator
Surface Type: Grass
Item Quantity: 1
Equipment Compliance: N/A
Surface Area Compliance: N/A

The lid or door of the litter bin is not secured - Ensure the lid or door is kept locked

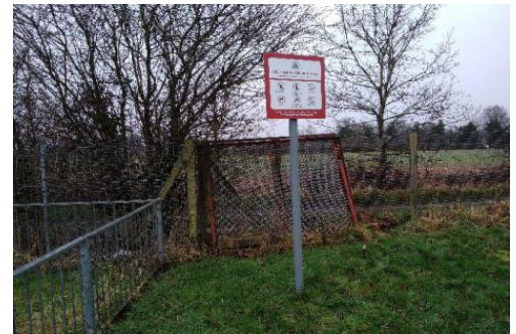
Item: Sign
Manufacturer: Owner/Operator
Surface Type: Grass
Item Quantity: 1
Equipment Compliance: N/A
Surface Area Compliance: N/A

BS EN 1176 Part 7 recommends that signage shall include the site name / address - Provide additional information

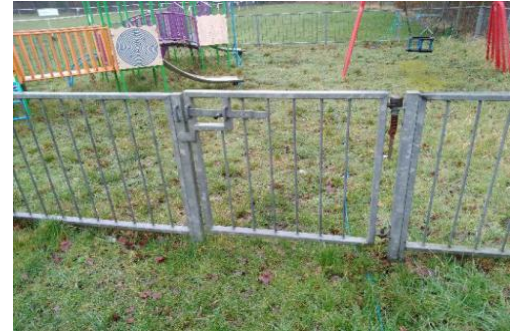
Item: Gate - Self Closing
Manufacturer: Owner/Operator
Surface Type: Grass
Item Quantity: 1
Equipment Compliance: N/A
Surface Area Compliance: N/A

The rubber buffer is missing from the latch plate - Replace rubber buffer

There are openings that are less than 12mm that could trap or crush fingers - Where possible a 12mm gap should be maintained on both sides or between the gate leaves

The gate spring cover is missing - Replace the spring cover

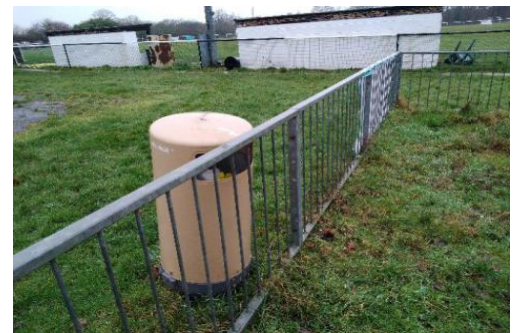
Item: Fencing - Flat Top
Manufacturer: Owner/Operator
Surface Type: Grass
Item Quantity: 1
Equipment Compliance: N/A
Surface Area Compliance: N/A

There is some damage to the fence sections - Monitor for any further deterioration and repair as required

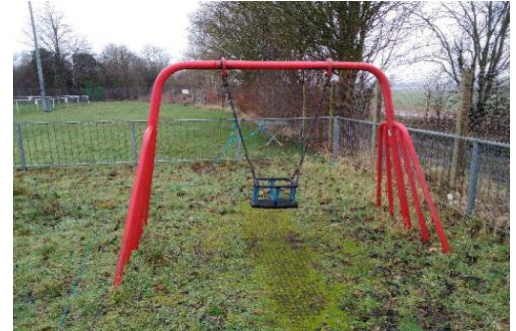
Item: 1 Bay 1 Seat (Cradle) - Type 1
Manufacturer: Wicksteed Playgrounds
Surface Type: Grass Matrix Tiles
Item Quantity: 1
Equipment Compliance: No
Surface Area Compliance: Yes

There is algae or moss growth on the surface resulting in slippery conditions - Clean and treat appropriately

The seat has minor damage or wear - Monitor for any further deterioration and replace as required

The chain openings are in excess of the 8.6mm as recommended by BS EN 1176 - Monitor - No remedial work recommended

There is some notable evidence of chain wear - Monitor for any further deterioration and replace when 40% worn

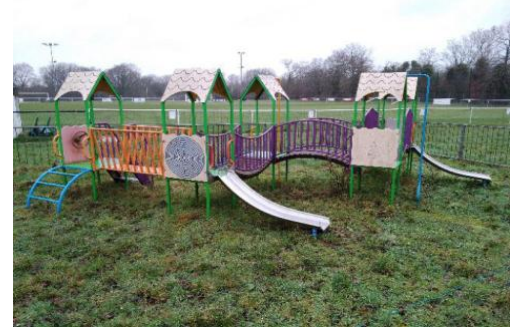
Item: Multi Play (Toddler)
Manufacturer: Wicksteed Playgrounds
Surface Type: Grass Matrix Tiles
Item Quantity: 1
Equipment Compliance: No
Surface Area Compliance: Yes

The height of the barrier(s) is insufficient and fails to meet the requirements of BS EN 1176 Part 1 - Monitor - No remedial work recommended

There is algae or moss on the surface of the equipment - Clean and treat appropriately

There is/are several inserts missing - Replace missing inserts

There is some evidence of rot in the timber - Monitor for any further deterioration and replace as required

The free space between the fireman's pole and the platform is less than the minimum recommended dimension of 350mm in BS EN 1176 Part 1; this is however an intended design feature by the manufacturer to assist younger users in accessing the pole and is a very low risk finding - no remedial action is recommended - Monitor - No remedial work recommended

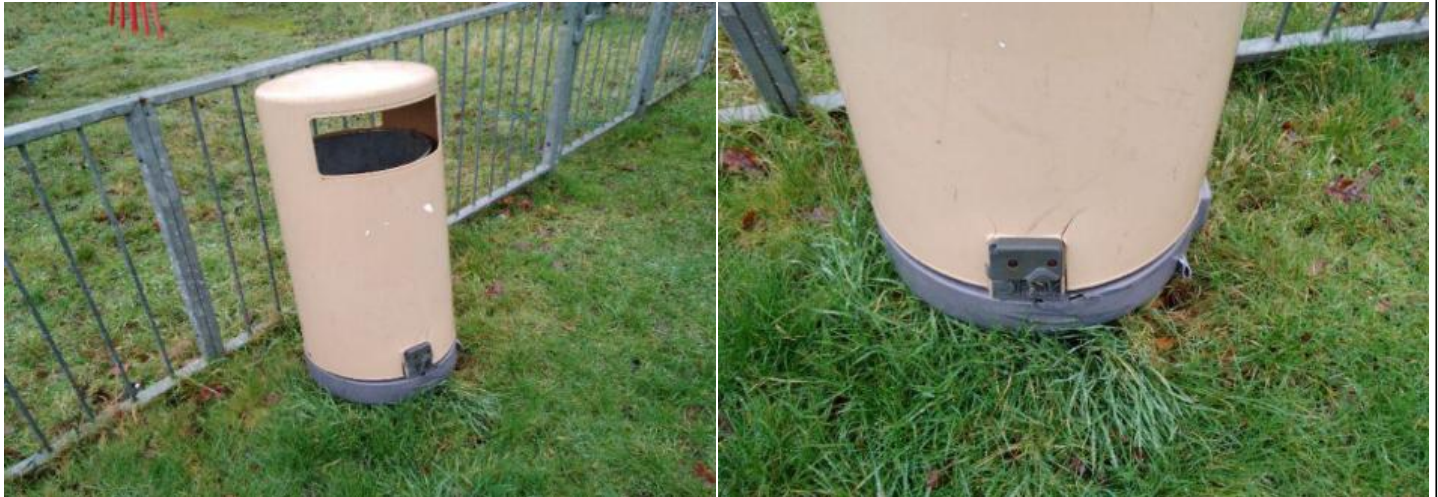
Finding: The lid or door of the litter bin is not secured

Action: Ensure the lid or door is kept locked

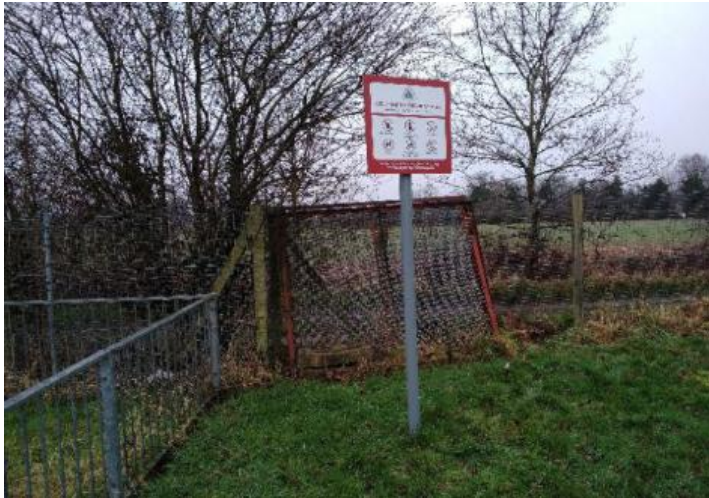
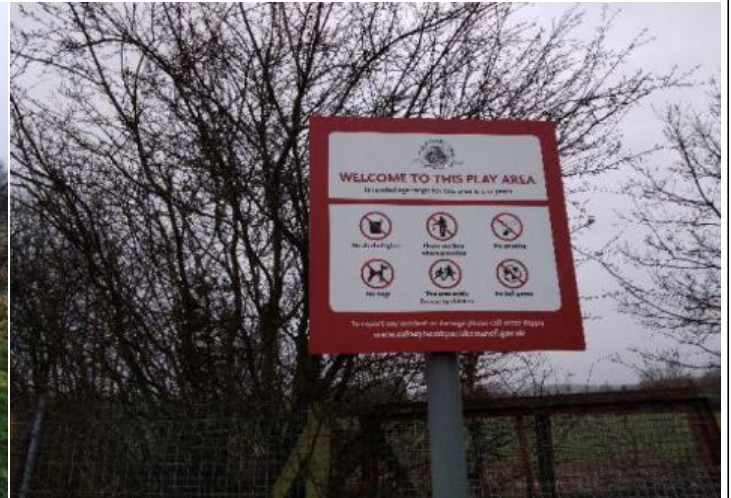
Finding: BS EN 1176 Part 7 recommends that signage shall include the site name / address **Action:** Provide additional information

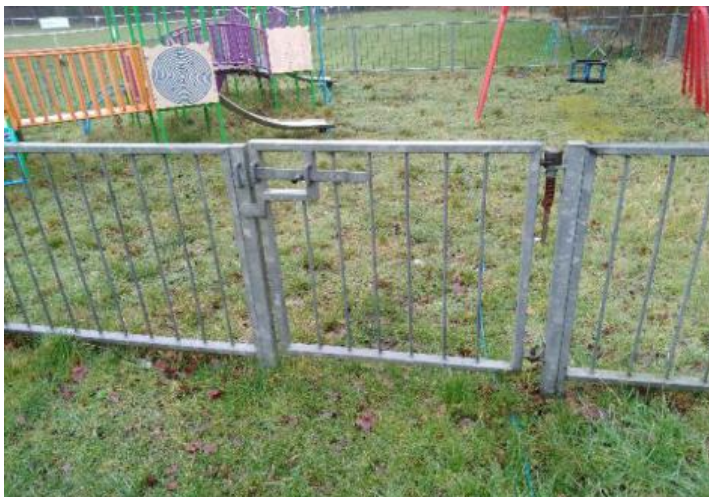
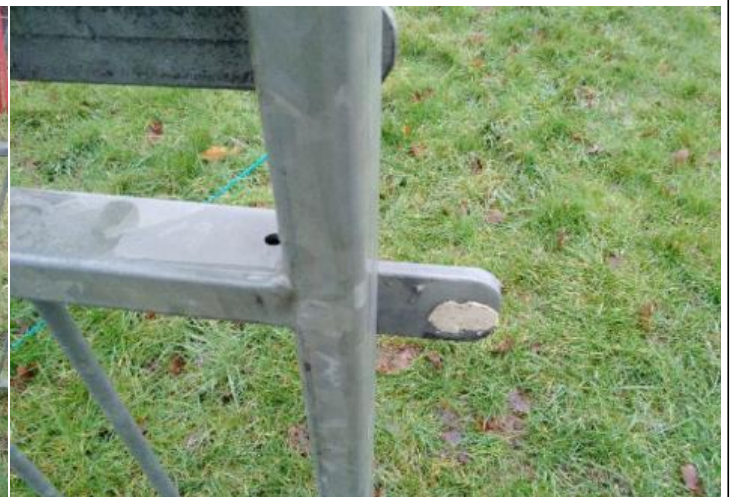
Finding: The rubber buffer is missing from the latch plate **Action:** Replace rubber buffer

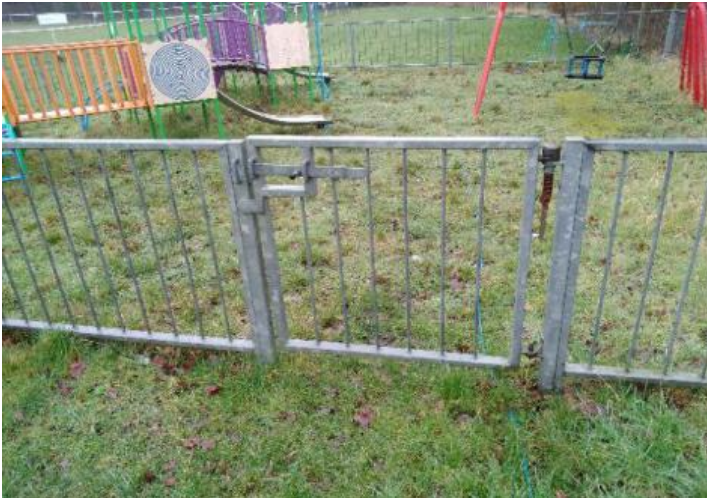
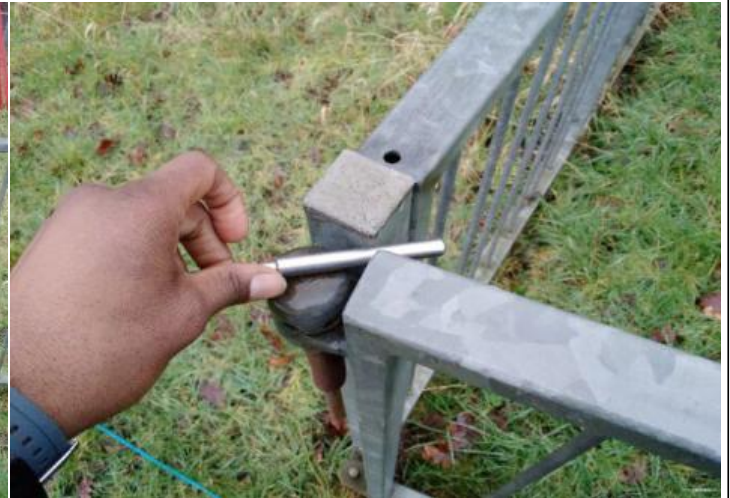
Finding: There are openings that are less than 12mm that could trap or crush fingers

Action: Where possible a 12mm gap should be maintained on both sides or between the gate leaves

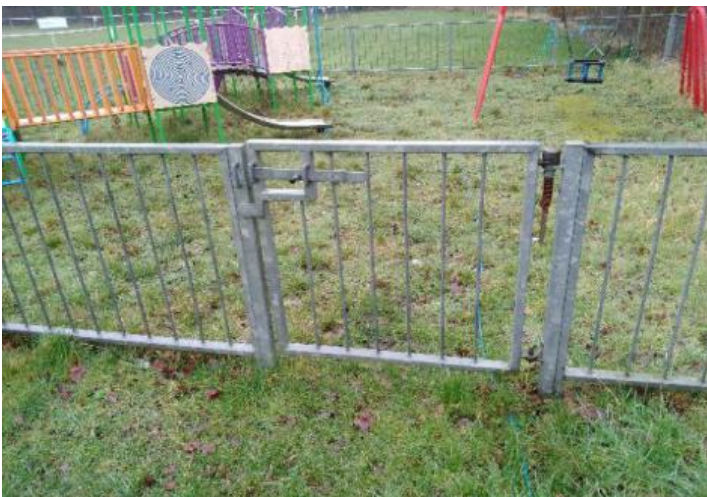
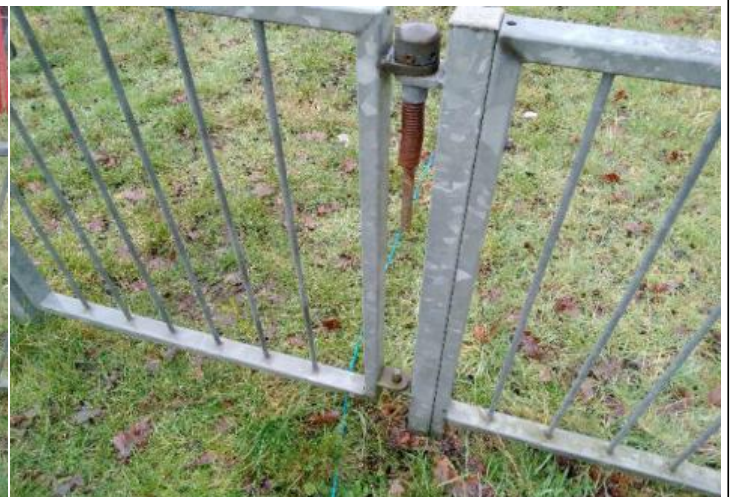
Finding: The gate spring cover is missing

Action: Replace the spring cover

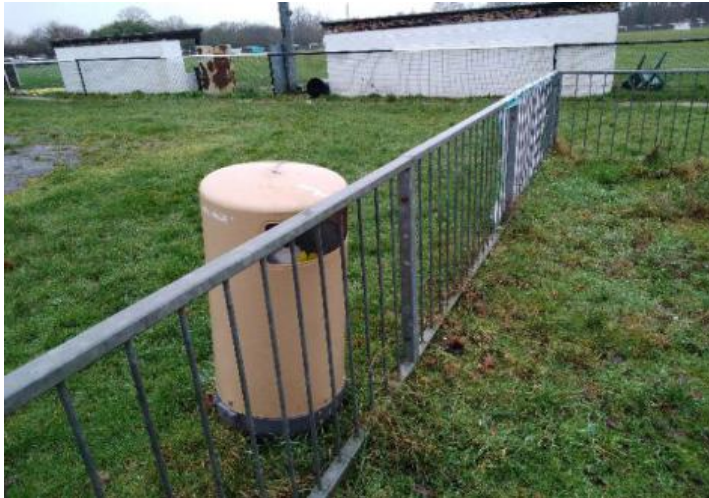
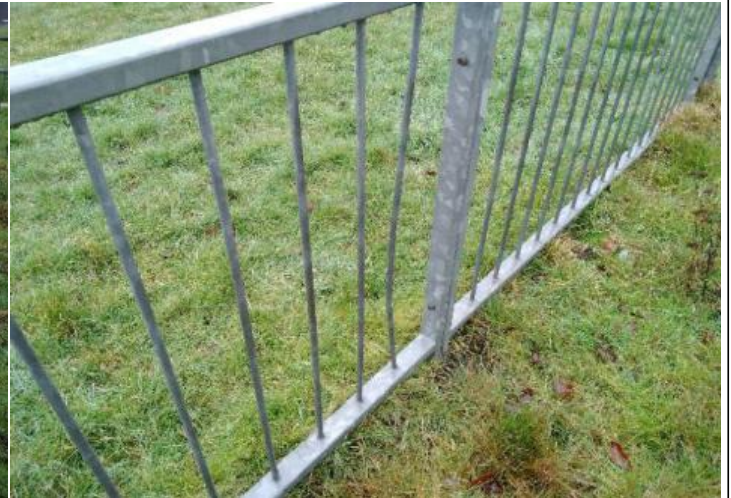
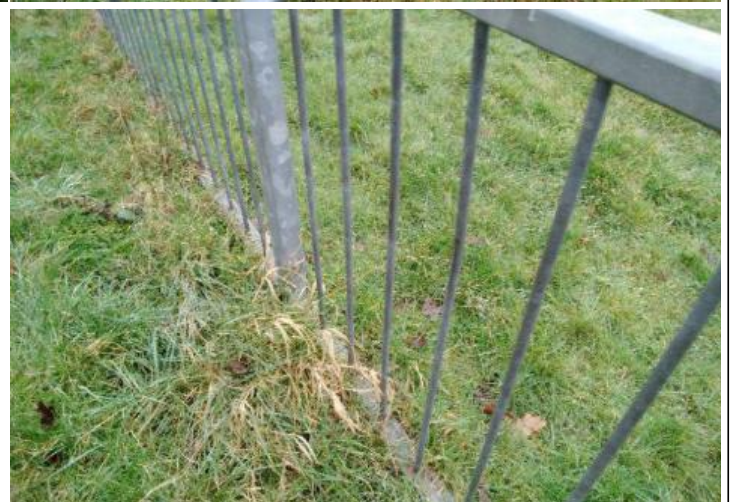
Finding: There is some damage to the fence sections

Action: Monitor for any further deterioration and repair as required

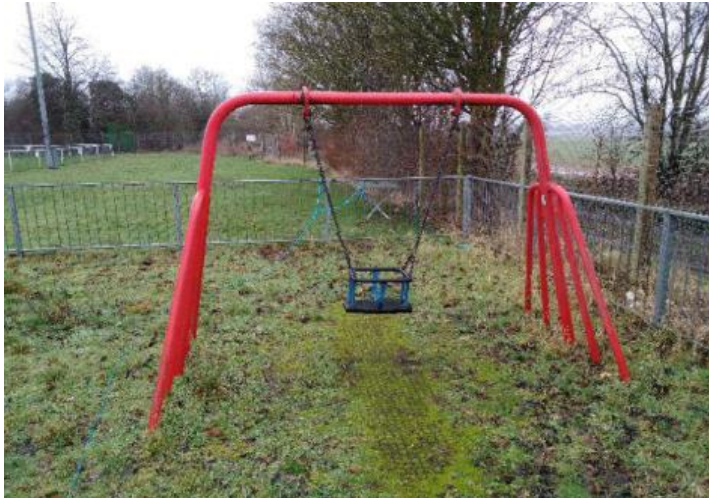
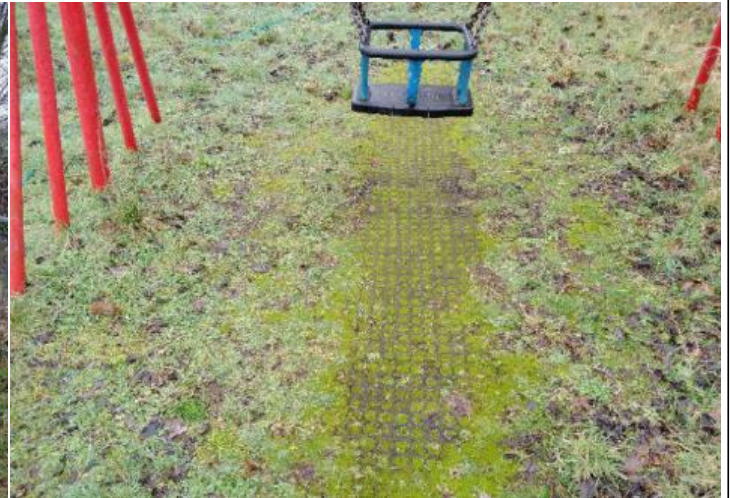
Finding: There is algae or moss growth on the surface resulting in slippery conditions

Action: Clean and treat appropriately

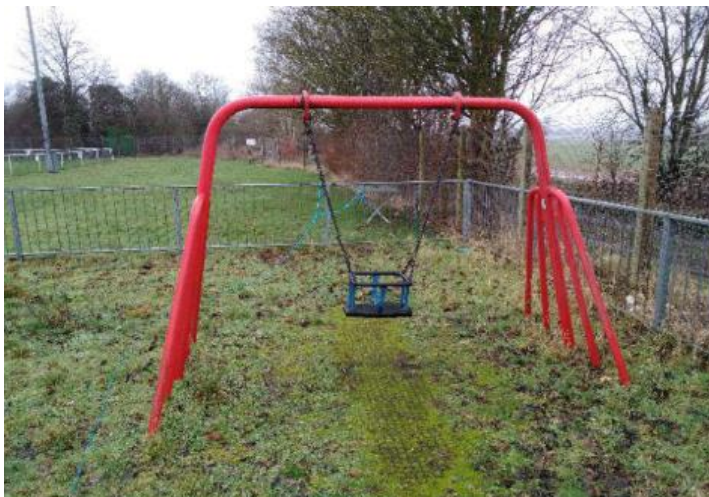
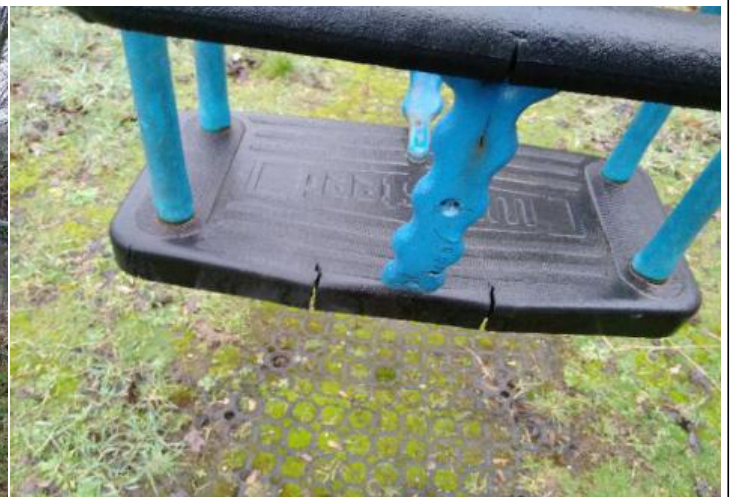
Finding: The seat has minor damage or wear

Action: Monitor for any further deterioration and replace as required

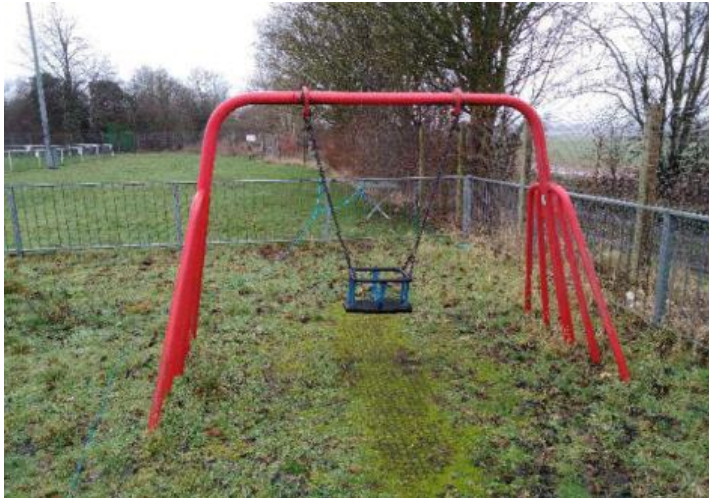
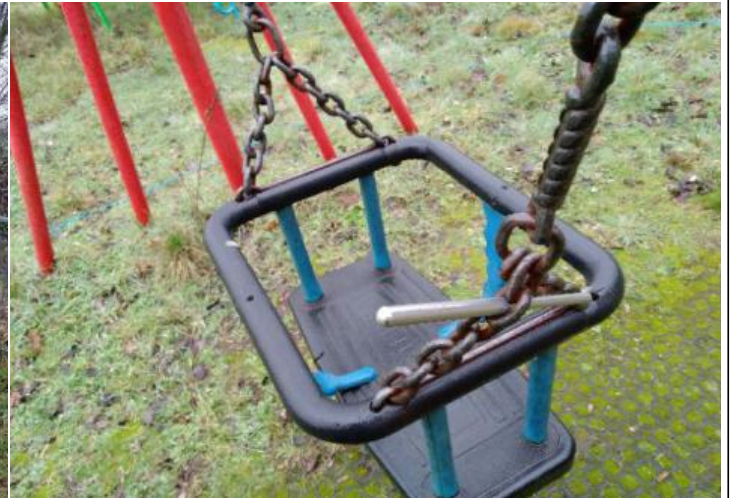
Finding: The chain openings are in excess of the 8.6mm as recommended by BS EN 1176 **Action:** Monitor - No remedial work recommended

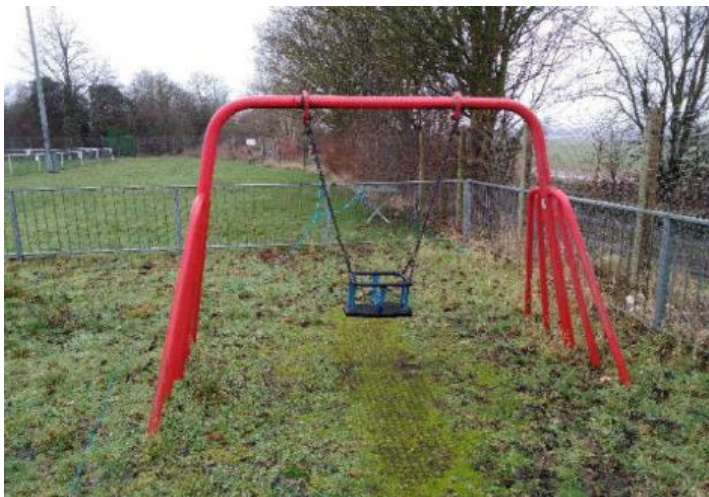
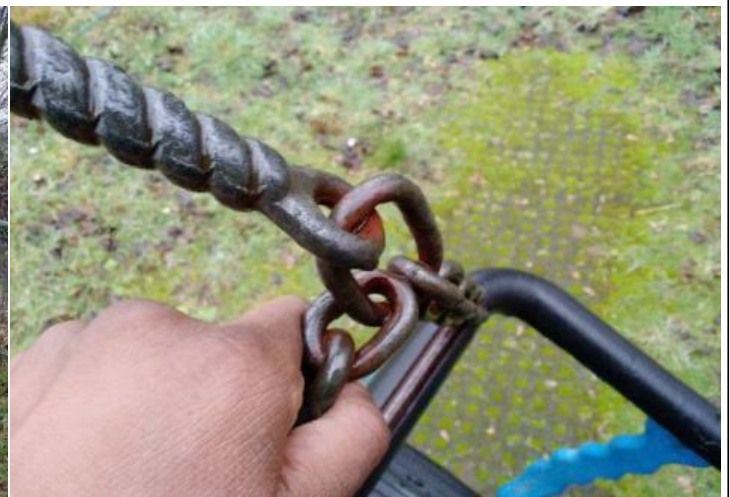
Finding: There is some notable evidence of chain wear **Action:** Monitor for any further deterioration and replace when 40% worn

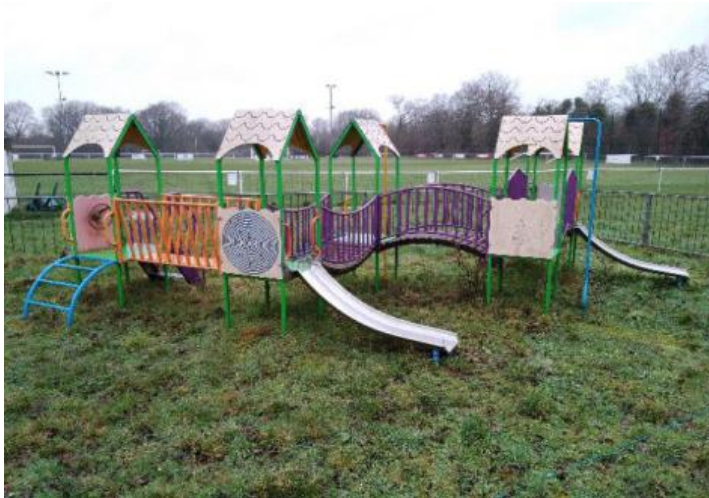
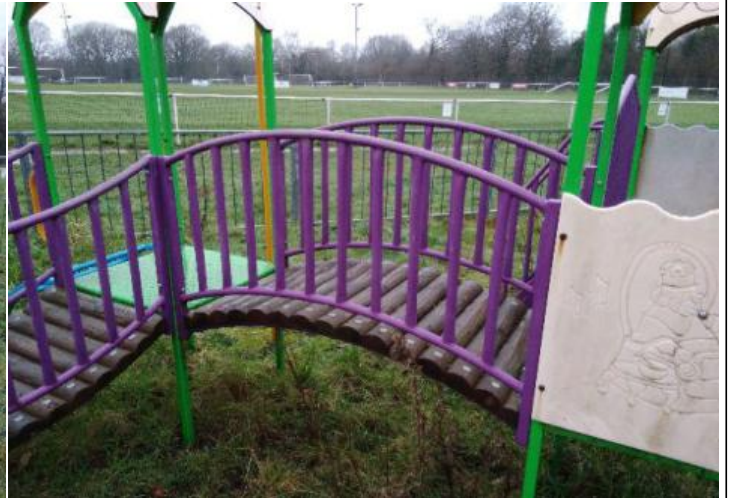
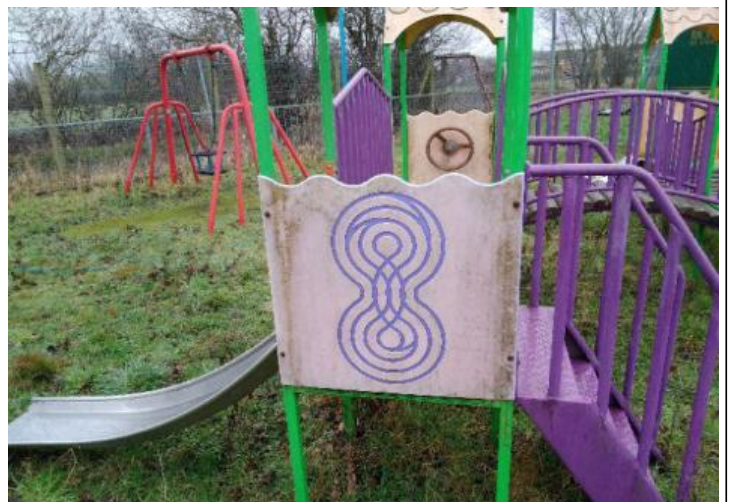
Finding: The height of the barrier(s) is insufficient and fails to meet the requirements of BS EN 1176 Part 1

Action: Monitor - No remedial work recommended

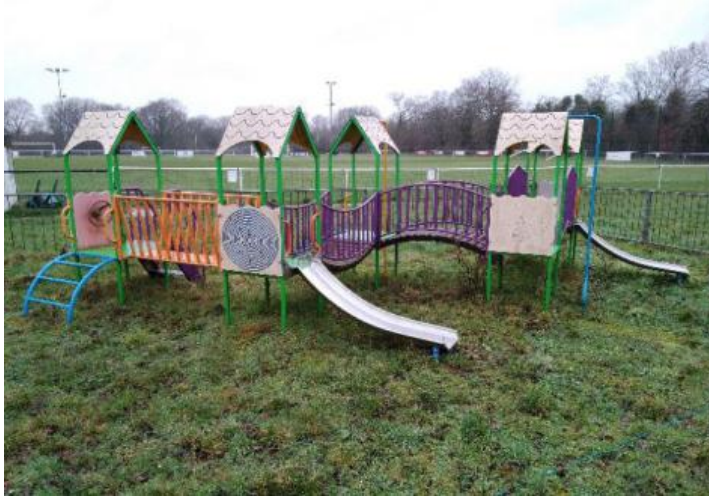
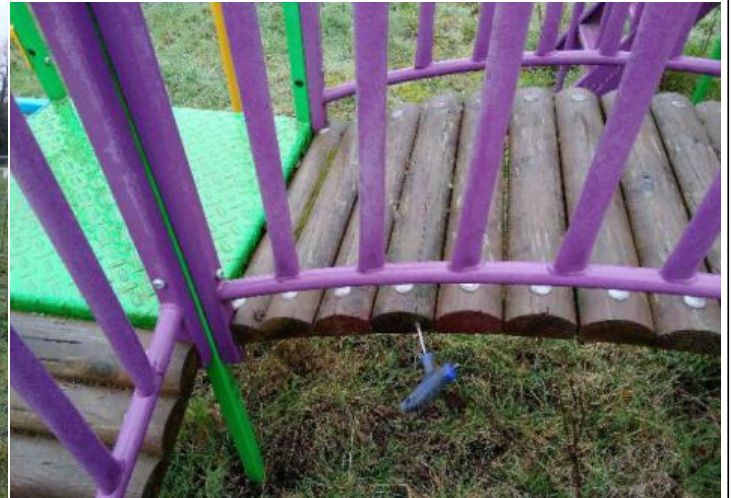
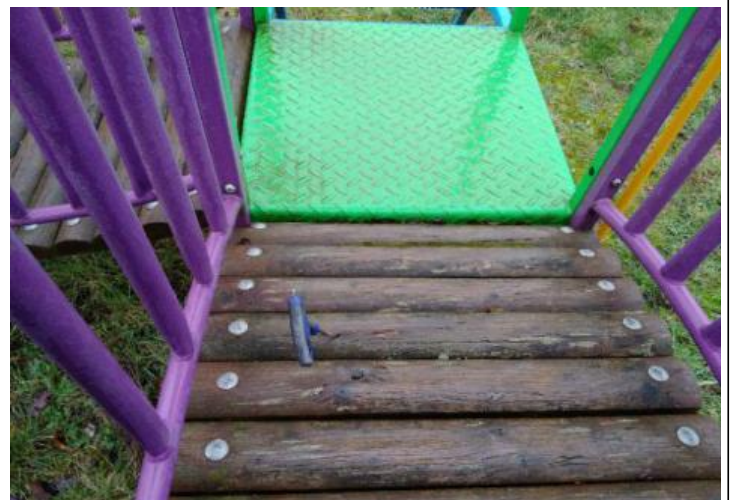
Finding: There is some evidence of rot in the timber

Action: Monitor for any further deterioration and replace as required

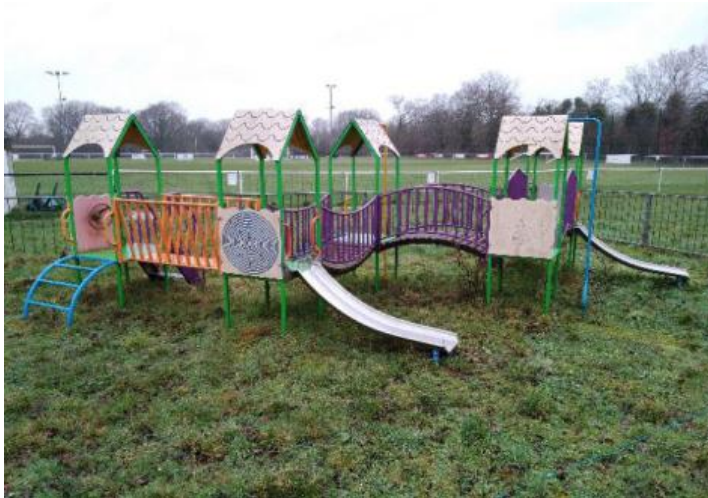
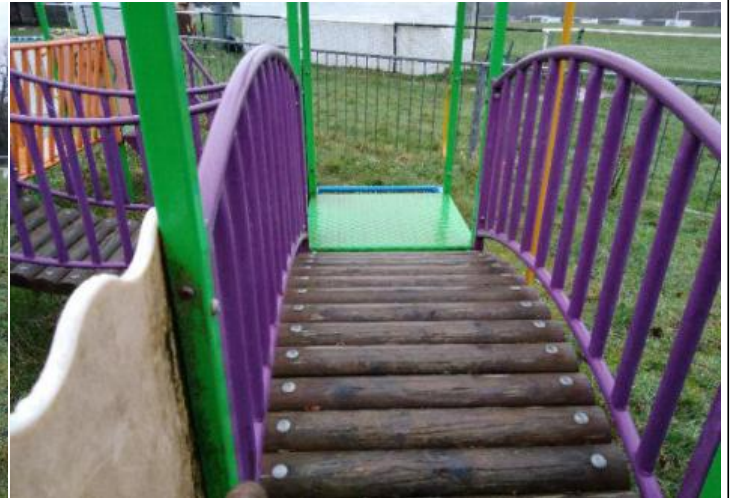
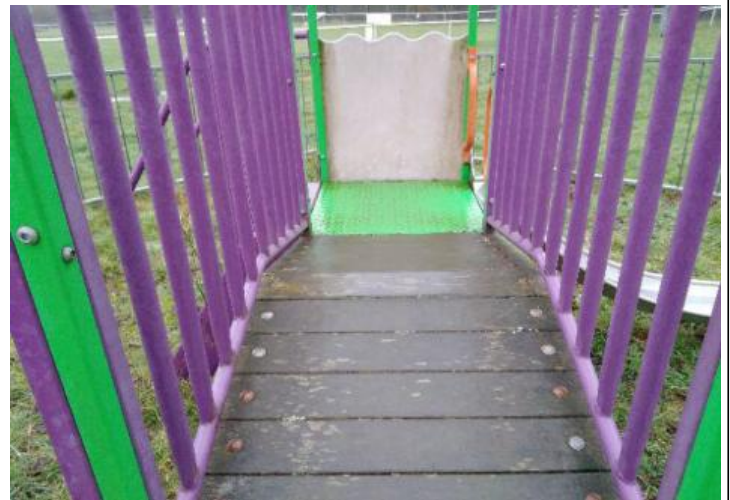
Finding: There is algae or moss on the surface of the equipment

Action: Clean and treat appropriately

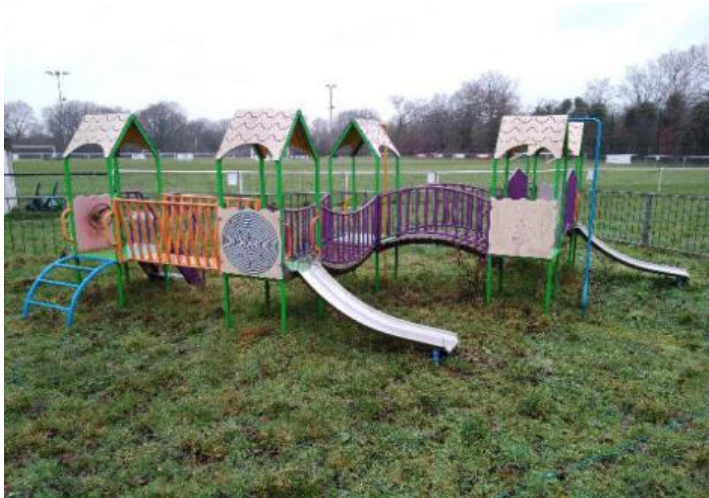
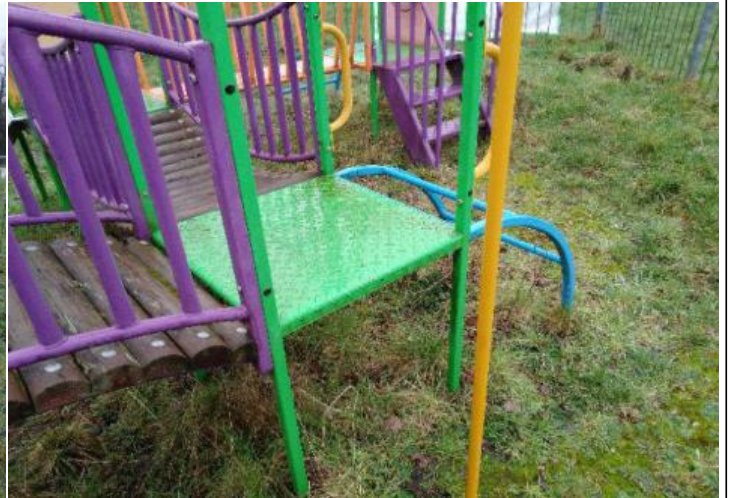
Finding: The free space between the fireman's pole and the platform is less than the minimum recommended dimension of 350mm in BS EN 1176 Part 1; this is however an intended design feature by the manufacturer to assist younger users in accessing the pole and is a very low risk finding - no remedial action is recommended
Action: Monitor - No remedial work recommended

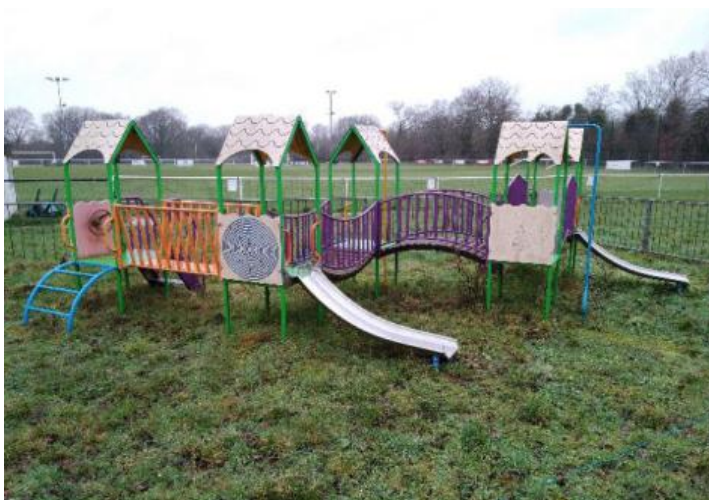
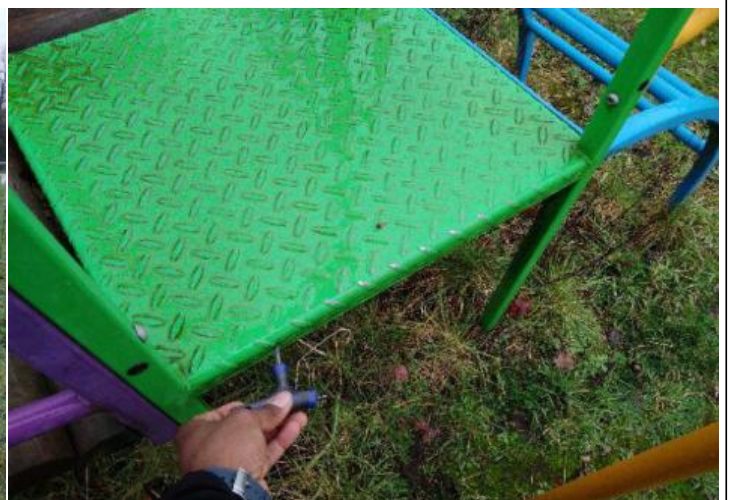
Finding: There is/are several inserts missing
Action: Replace missing inserts
