the play inspection company

Annual Inspection

St Albans City and District Council

Roestock Park

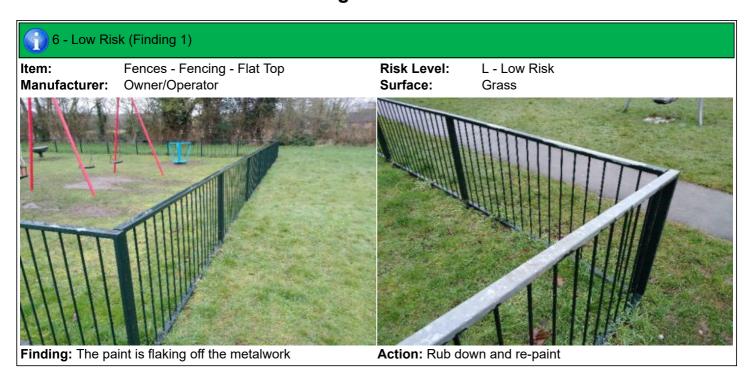
Item:Fences - Fencing - Flat TopRisk Level:L - Low RiskManufacturer:Owner/OperatorSurface:Grass

Finding: There is some damage to the fence sections

Action: Monitor for any further deterioration and repair as required

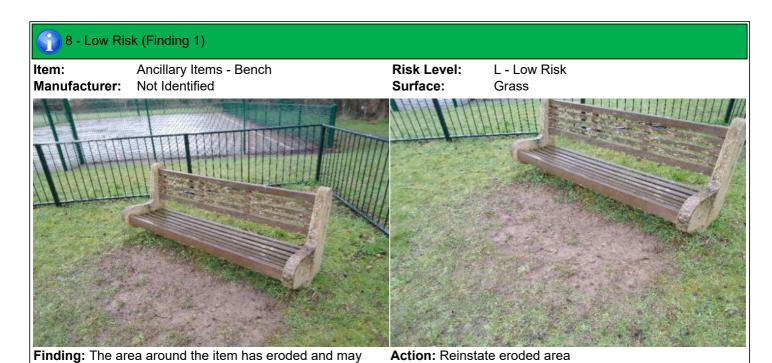
become slippery

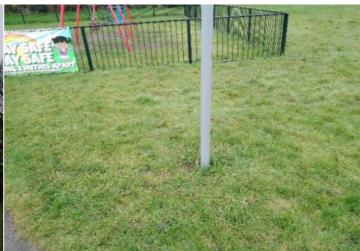
The item is slightly loose in its foundations - Monitor for any further deterioration and repair as required

Item:Ancillary Items - SignRisk Level:L - Low RiskManufacturer:Owner/OperatorSurface:Grass

Action: Monitor for any further deterioration and repair as required

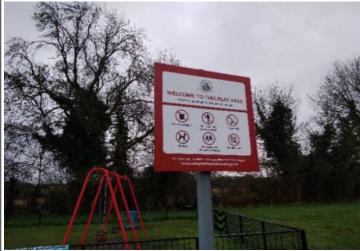
Item: Ancillary Items - Sign Risk Level: V - Very Low Risk

Finding: BS EN 1176 Part 7 recommends that signage shall **Action:** Provide additional information include the site name / address

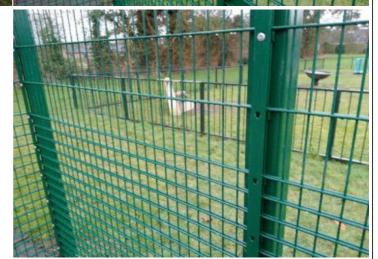
Finding: There is/are missing fixings creating finger entrapments in the surround and the item fails to meet the requirements of BS EN 15312 Clause 4.4.2.2 Entrapment of fingers

Action: Replace the missing fixings to remove the entrapment from the equipment

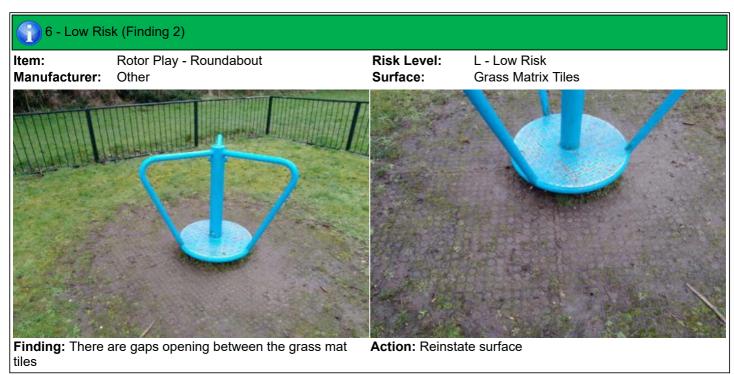
of the grass mats

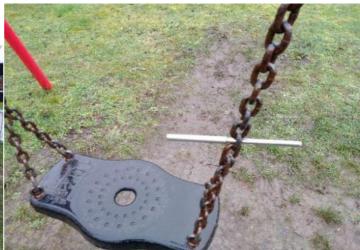
Item: Swings - 2 Bay 2 Flat 1 Cradle Seat Risk Level: V - Very Low Risk Manufacturer: Not Identified Surface: Grass Matrix Tiles

Finding: The chain openings are in excess of the 8.6mm as **Action:** Monitor - No remedial work recommended recommended by BS EN 1176

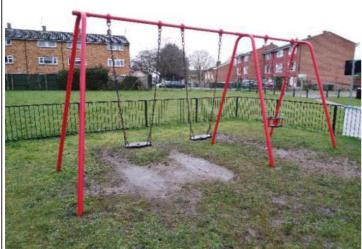
Finding: BS EN 1176 Part 2: Annex A makes a recommendation that fences or enclosures should be upto 1m from the edges of the swing seat to the sides, and subject to risk assessment, from the edge of the impact area. This is however, a low risk finding and no remedial action is recommended.

Action: Monitor - No remedial work recommended

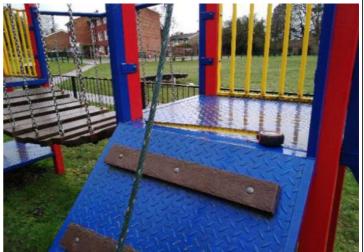
Item:Activity Equipment - Multi Play (Junior)Risk Level:L - Low RiskManufacturer:Safe & SoundSurface:Grass Matrix Tiles

Finding: The unit is easily accessible and has an opening in **Action:** Monitor - No remedial work recommended the barrier to steep play elements in excess of 500mm in contravention of BS EN 1176 Part 1

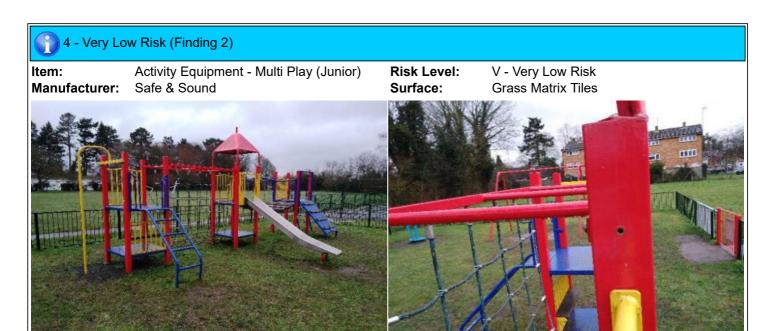
Finding: There is/are several inserts missing

Action: Replace missing inserts
