## Annual Inspection

St Albans City and District Council

Sleapshyde Park

Inspection Ref: 1294385

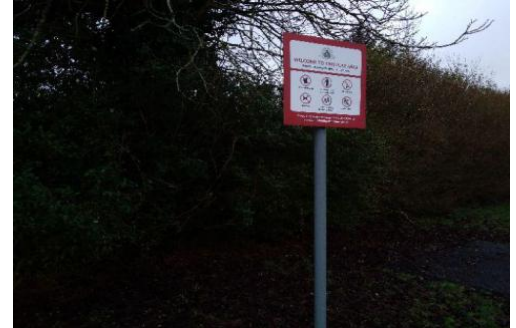
**Item:** Sign  
**Manufacturer:** Owner/Operator  
**Surface Type:** Grass  
**Item Quantity:** 1  
**Equipment Compliance:** N/A  
**Surface Area Compliance:** N/A

BS EN 1176 Part 7 recommends that signage shall include the site name / address - Provide additional information

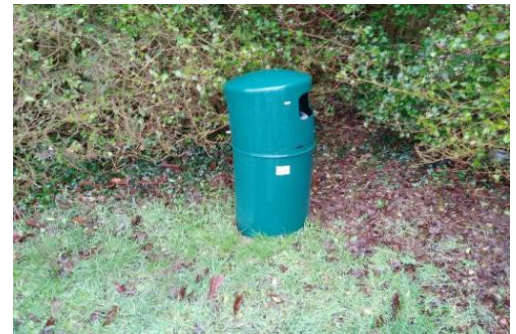
**Item:** Litter Bin  
**Manufacturer:** Owner/Operator  
**Surface Type:** Grass  
**Item Quantity:** 1  
**Equipment Compliance:** N/A  
**Surface Area Compliance:** N/A

The lid or door of the litter bin is not secured - Ensure the lid or door is kept locked

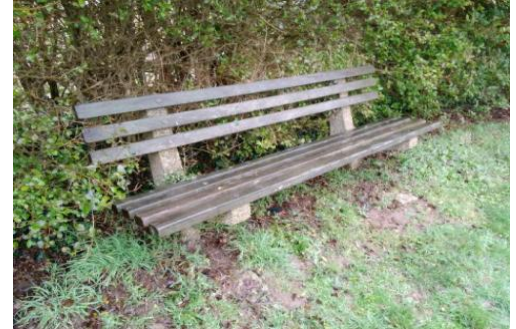
**Item:** Bench  
**Manufacturer:** Owner/Operator  
**Surface Type:** Grass  
**Item Quantity:** 1  
**Equipment Compliance:** N/A  
**Surface Area Compliance:** N/A

The surface has eroded and the foundations are exposed - Reinstate surrounding surfaces to cover the foundations

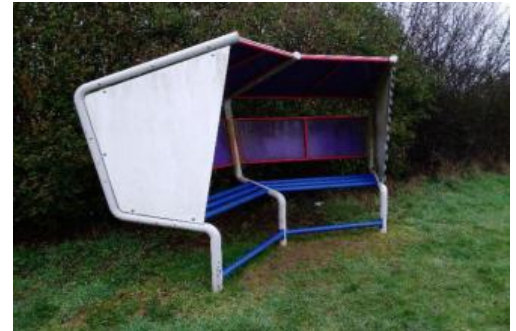
**Item:** Shelter  
**Manufacturer:** Not Identified  
**Surface Type:** Grass  
**Item Quantity:** 1  
**Equipment Compliance:** N/A  
**Surface Area Compliance:** N/A

This item is satisfactory - no work required -

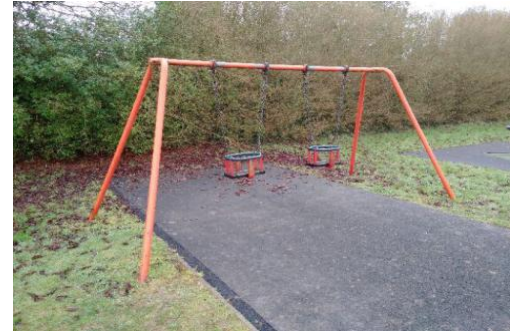
**Item:** 1 Bay 2 Seat (Cradle)  
**Manufacturer:** Not Identified  
**Surface Type:** Wet Pour  
**Item Quantity:** 1  
**Equipment Compliance:** Yes  
**Surface Area Compliance:** Yes

The paint is flaking off the metalwork - Rub down and re-paint

The surfacing around the item is damaged - Repair the damaged areas of surfacing

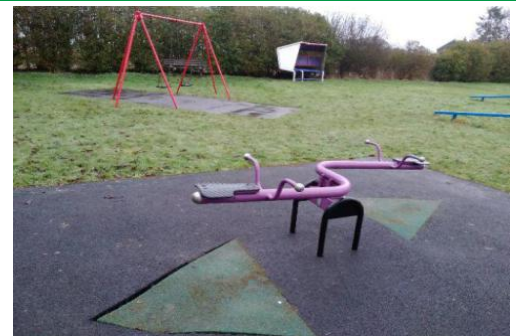
**Item:** See Saw  
**Manufacturer:** Wicksteed Playgrounds  
**Surface Type:** Wet Pour  
**Item Quantity:** 1  
**Equipment Compliance:** Yes  
**Surface Area Compliance:** Yes

The surface has subsided in some areas - Monitor for any further deterioration and repair as required

There are significant gaps (over 30mm) between the surface and the edging or between the joints in the surface; these are large enough for a small foot to enter - Repair surfacing

There is algae or moss growth on the surface resulting in slippery conditions - Clean and treat appropriately

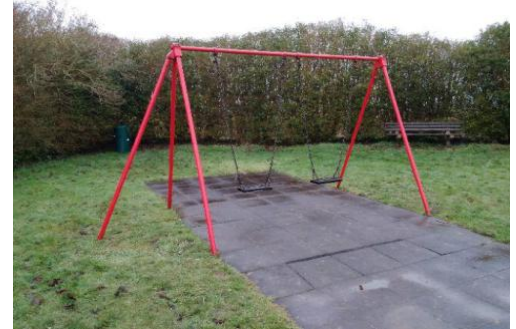
**Item:** 1 Bay 2 Seat (Flat)  
**Manufacturer:** G L Jones Playgrounds Ltd  
**Surface Type:** Rubber Tiles  
**Item Quantity:** 1  
**Equipment Compliance:** No  
**Surface Area Compliance:** Yes

The seat is severely damaged and requires replacing - Replace damaged seat

The chain openings are in excess of the 8.6mm as recommended by BS EN 1176 - Monitor - No remedial work recommended

There is some notable evidence of chain wear - Monitor for any further deterioration and replace when 40% worn

The bushes are showing signs of wear - Monitor for any further deterioration and replace as required

The surface has subsided in some areas - Monitor for any further deterioration and repair as required

There are gaps opening in between the tiles - Monitor for any further deterioration and repair as required

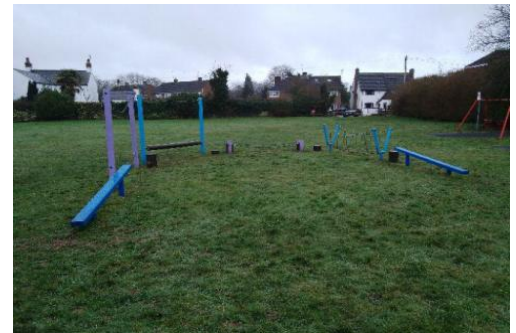
**Item:** Activity Trail  
**Manufacturer:** Not Identified  
**Surface Type:** Grass  
**Item Quantity:** 1  
**Equipment Compliance:** Yes  
**Surface Area Compliance:** Yes

A number of fixing(s) have worked loose - Secure all loose fixings

There is or are fixings missing on the item - Replace all missing fixings

There is algae or moss on the surface of the equipment - Clean and treat appropriately

The rotating beam housing has been installed upside down - Correct the positioning of the item

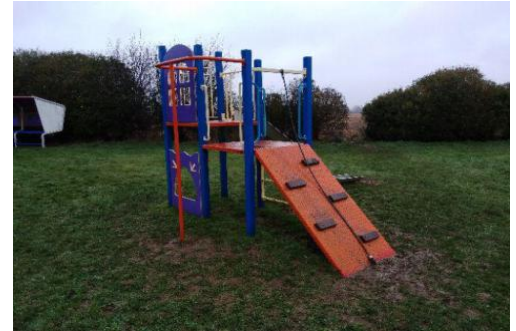
**Item:** Multi Play (Junior)  
**Manufacturer:** Not Identified  
**Surface Type:** Grass Matrix Tiles  
**Item Quantity:** 1  
**Equipment Compliance:** No  
**Surface Area Compliance:** Yes

The unit is easily accessible and has an opening in the barrier to steep play elements in excess of 500mm in contravention of BS EN 1176 Part 1 - Monitor - No remedial work recommended

There are a number of dents in the slide surface - Monitor for any further deterioration and repair as required

There is some evidence of fire damage to the item - Replace damaged component

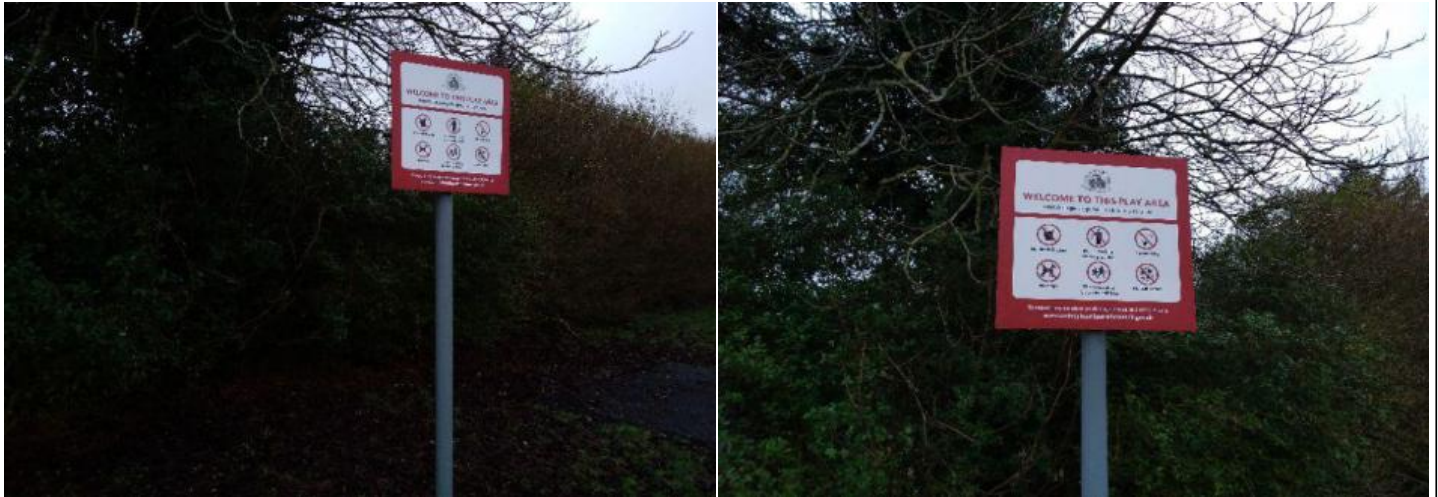
**Item:** Ancillary Items - Sign  
**Manufacturer:** Owner/Operator

**Finding:** BS EN 1176 Part 7 recommends that signage shall include the site name / address **Action:** Provide additional information

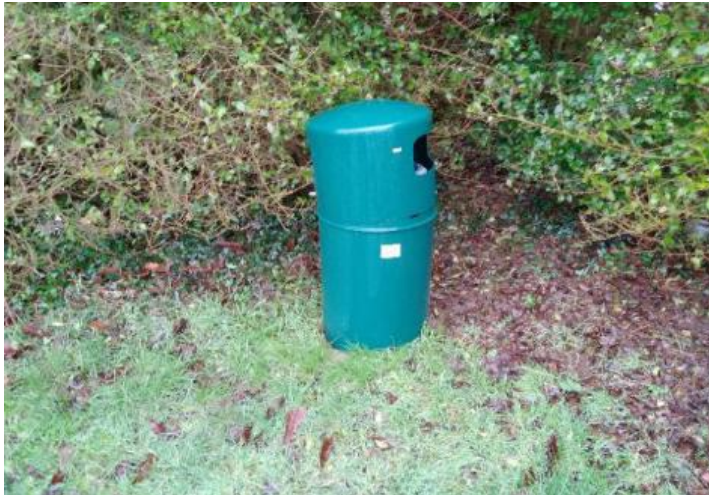
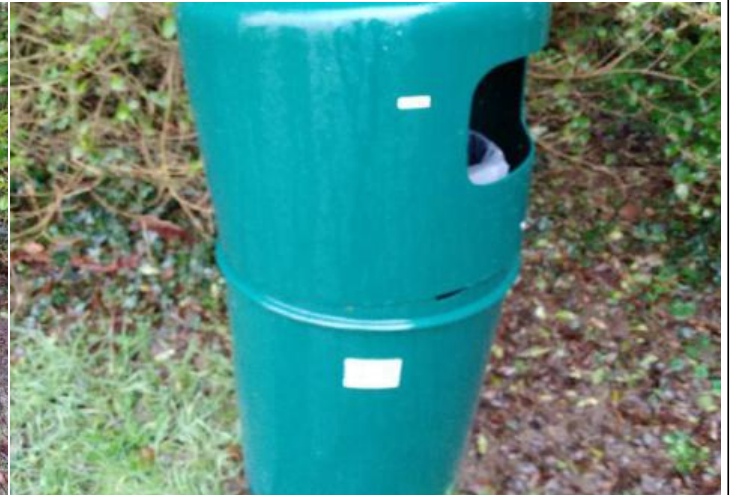
**Item:** Ancillary Items - Litter Bin  
**Manufacturer:** Owner/Operator

**Finding:** The lid or door of the litter bin is not secured

**Action:** Ensure the lid or door is kept locked

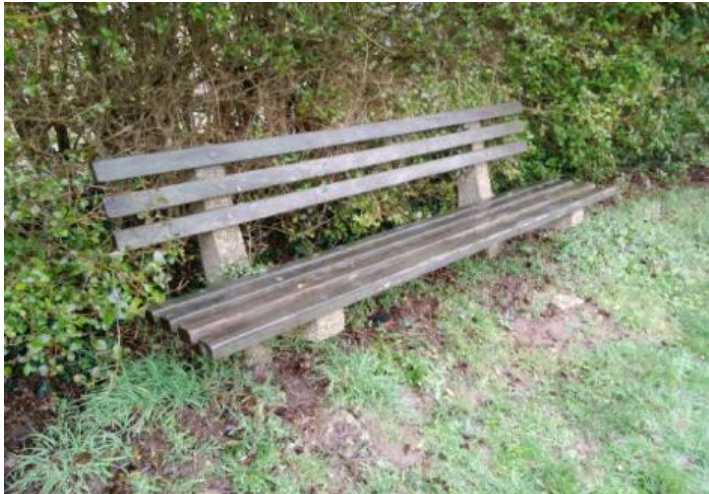
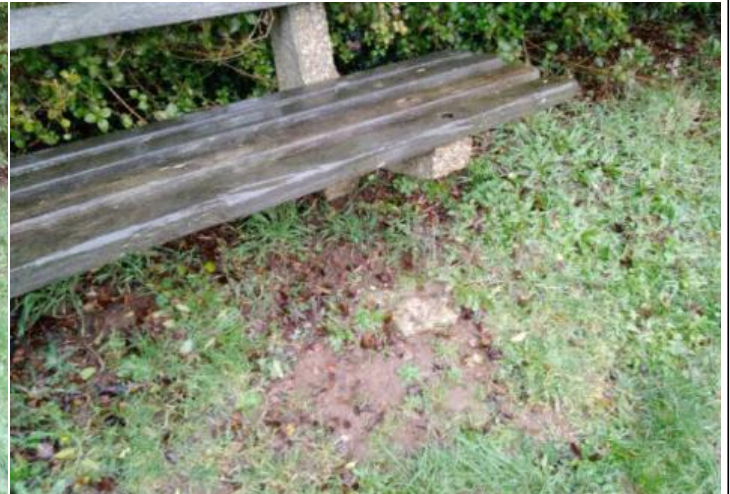
**Item:** Ancillary Items - Bench  
**Manufacturer:** Owner/Operator

**Finding:** The surface has eroded and the foundations are exposed

**Action:** Reinstate surrounding surfaces to cover the foundations

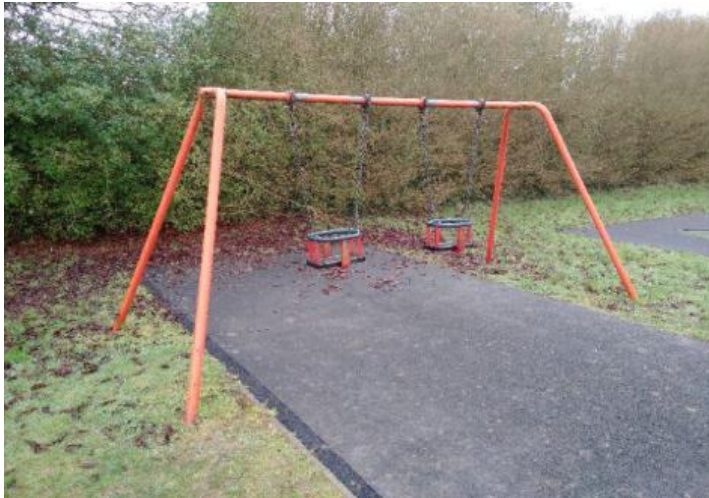
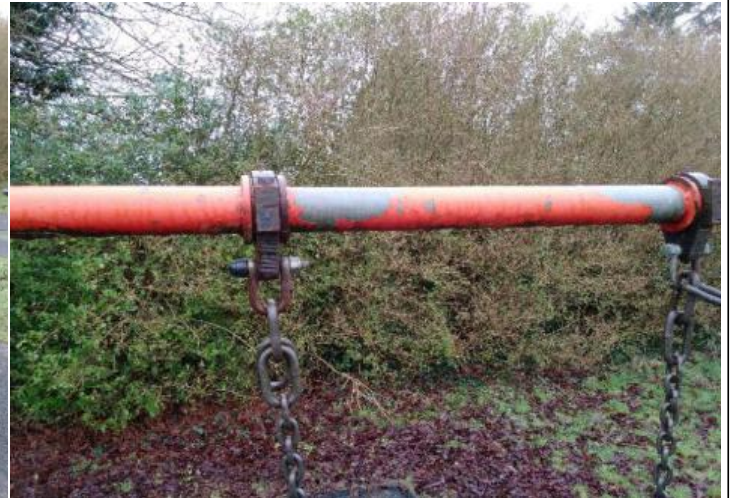
**Item:** Swings - 1 Bay 2 Seat (Cradle)  
**Manufacturer:** Not Identified

**Finding:** The paint is flaking off the metalwork

**Action:** Rub down and re-paint

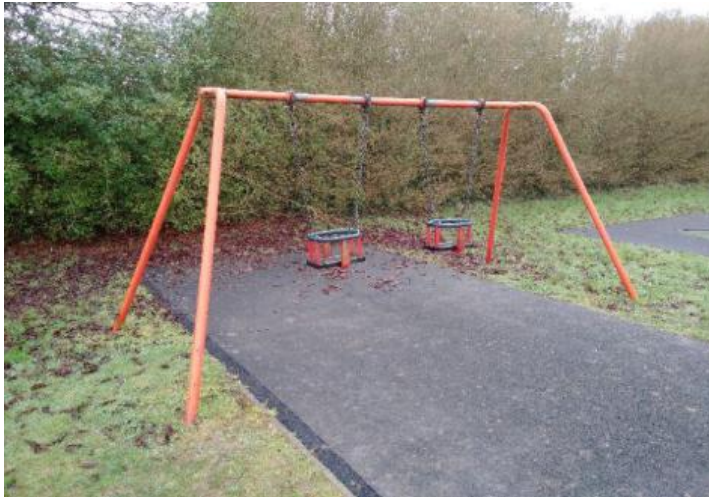
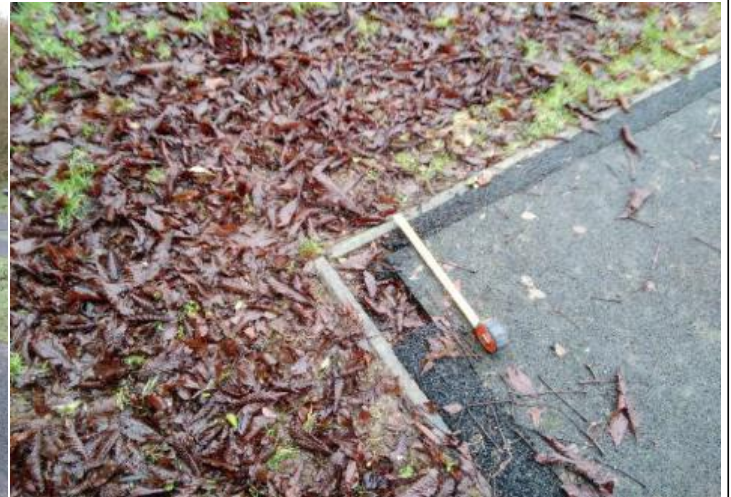
**Item:** Swings - 1 Bay 2 Seat (Cradle)  
**Manufacturer:** Not Identified

**Finding:** The surfacing around the item is damaged

**Action:** Repair the damaged areas of surfacing

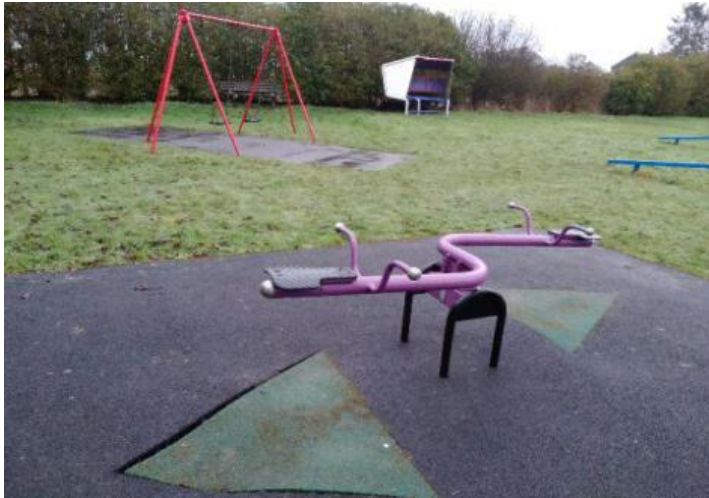
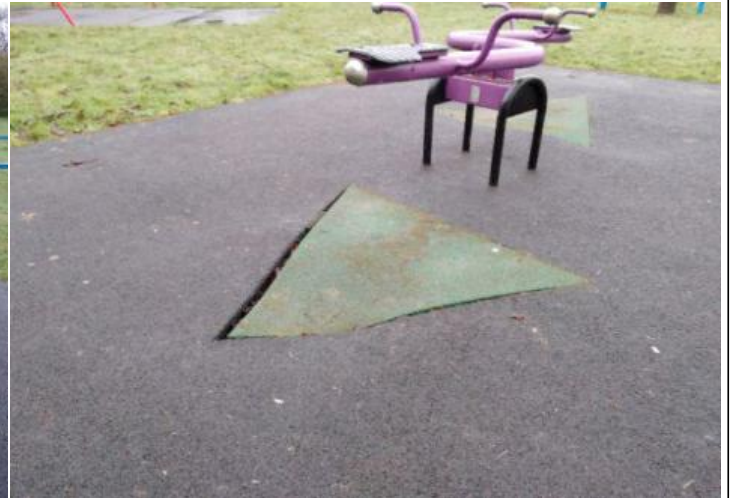
**Item:** Rocking Equipment - See Saw  
**Manufacturer:** Wicksteed Playgrounds

**Finding:** The surface has subsided in some areas

**Action:** Monitor for any further deterioration and repair as required

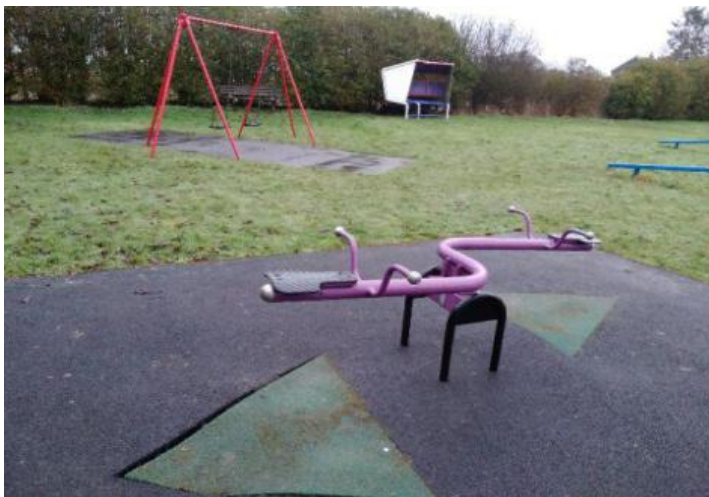
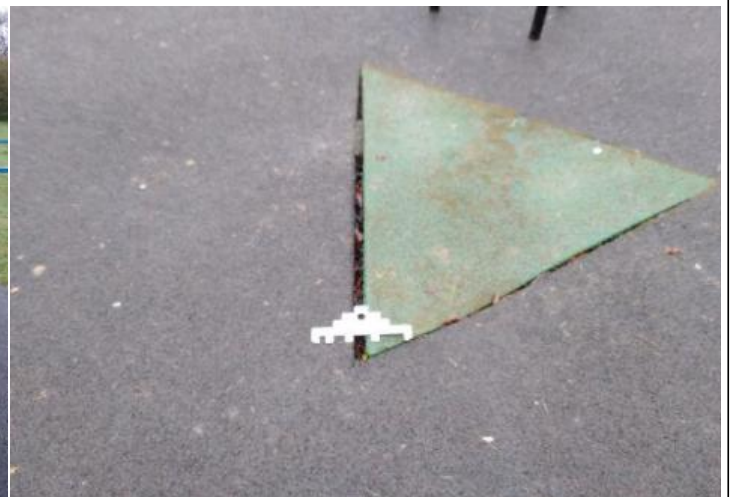
**Item:** Rocking Equipment - See Saw  
**Manufacturer:** Wicksteed Playgrounds

**Finding:** There are significant gaps (over 30mm) between the surface and the edging or between the joints in the surface; these are large enough for a small foot to enter

**Action:** Repair surfacing

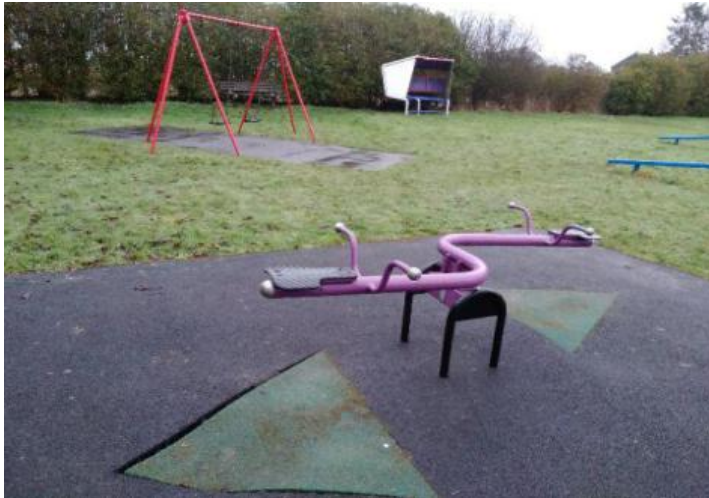
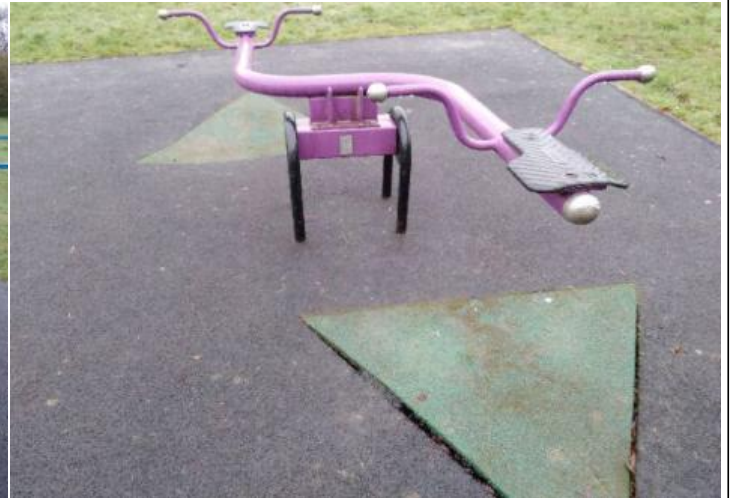
**Item:** Rocking Equipment - See Saw  
**Manufacturer:** Wicksteed Playgrounds

**Finding:** There is algae or moss growth on the surface resulting in slippery conditions

**Action:** Clean and treat appropriately

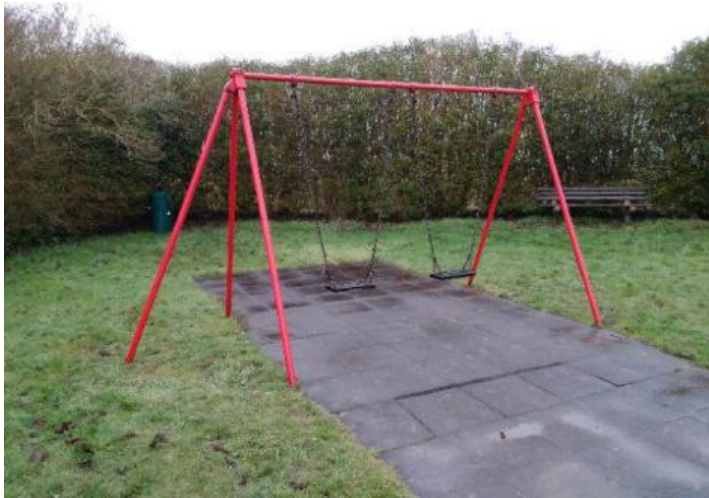
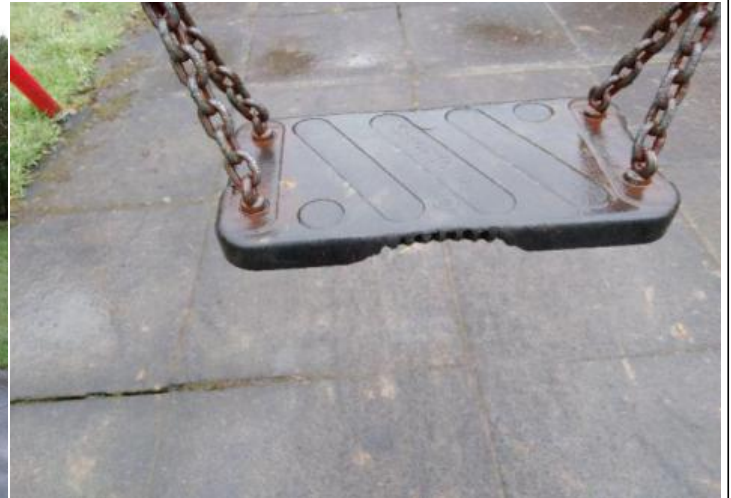
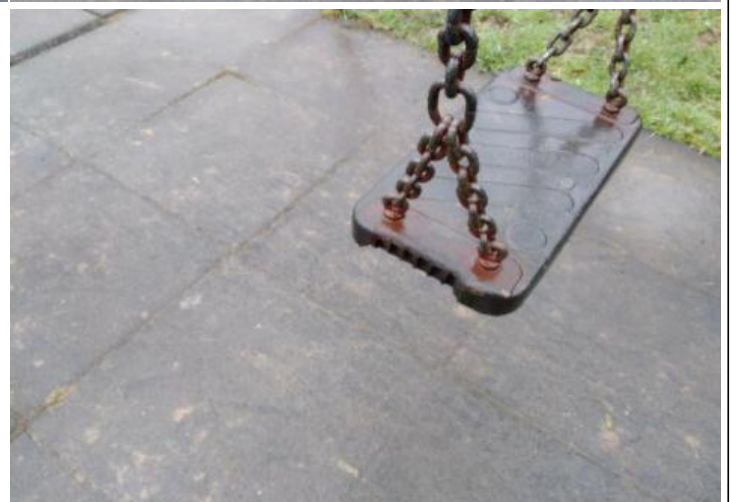
**Item:** Swings - 1 Bay 2 Seat (Flat)  
**Manufacturer:** G L Jones Playgrounds Ltd

**Finding:** The seat is severely damaged and requires replacing

**Action:** Replace damaged seat

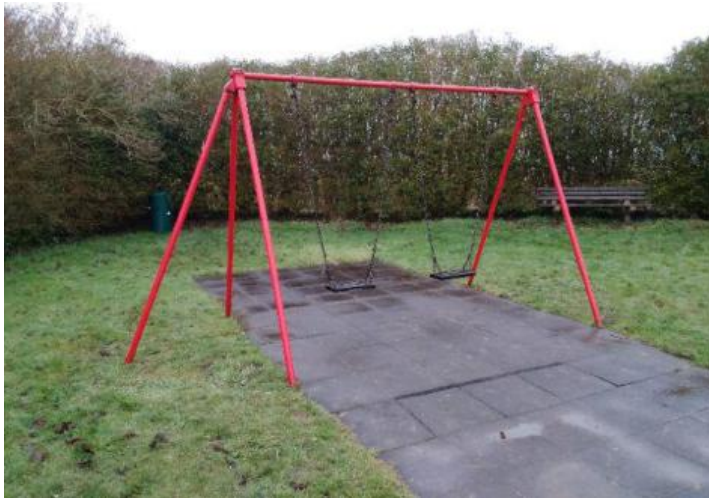
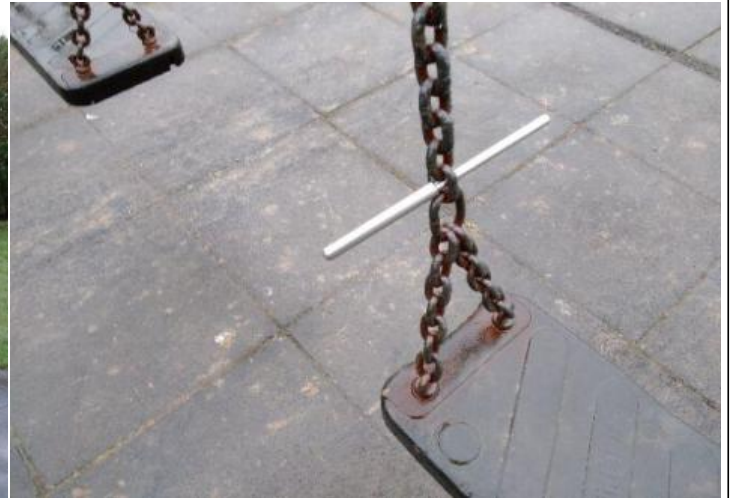
**Item:** Swings - 1 Bay 2 Seat (Flat)  
**Manufacturer:** G L Jones Playgrounds Ltd

**Finding:** The chain openings are in excess of the 8.6mm as recommended by BS EN 1176 **Action:** Monitor - No remedial work recommended

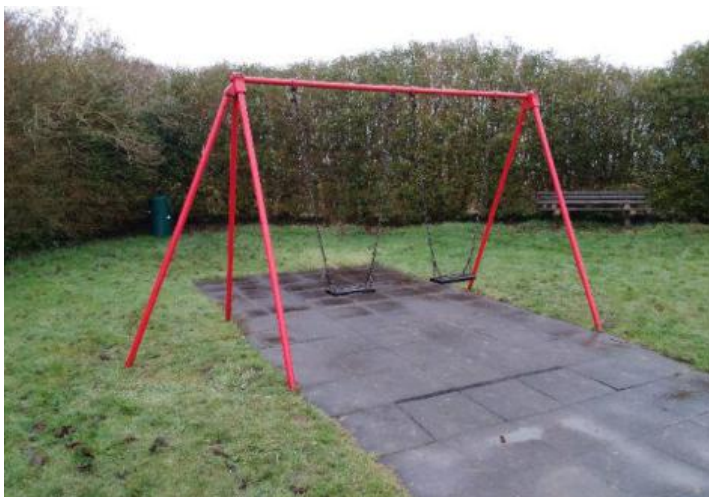
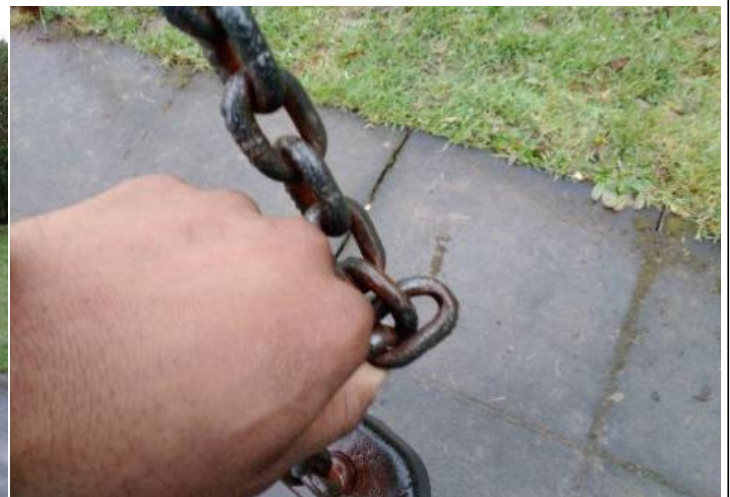
**Item:** Swings - 1 Bay 2 Seat (Flat)  
**Manufacturer:** G L Jones Playgrounds Ltd

**Finding:** There is some notable evidence of chain wear **Action:** Monitor for any further deterioration and replace when 40% worn

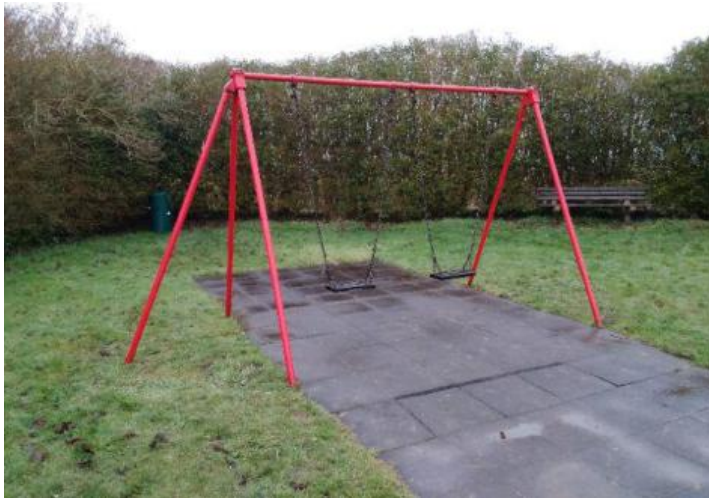
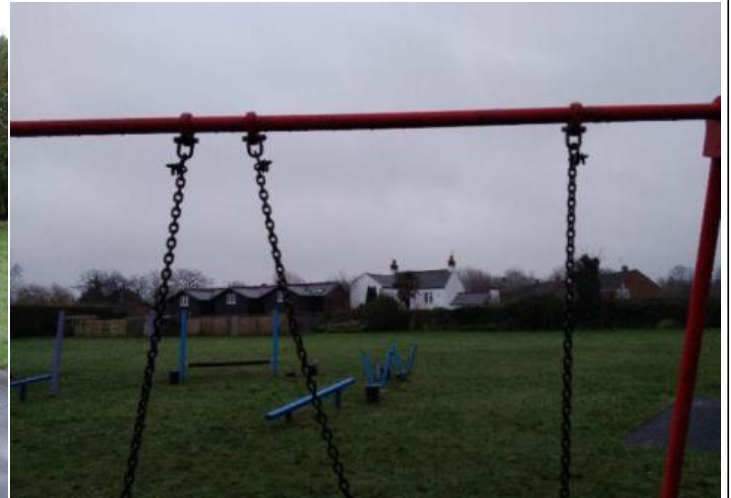
**Item:** Swings - 1 Bay 2 Seat (Flat)  
**Manufacturer:** G L Jones Playgrounds Ltd

**Finding:** The bushes are showing signs of wear

**Action:** Monitor for any further deterioration and replace as required

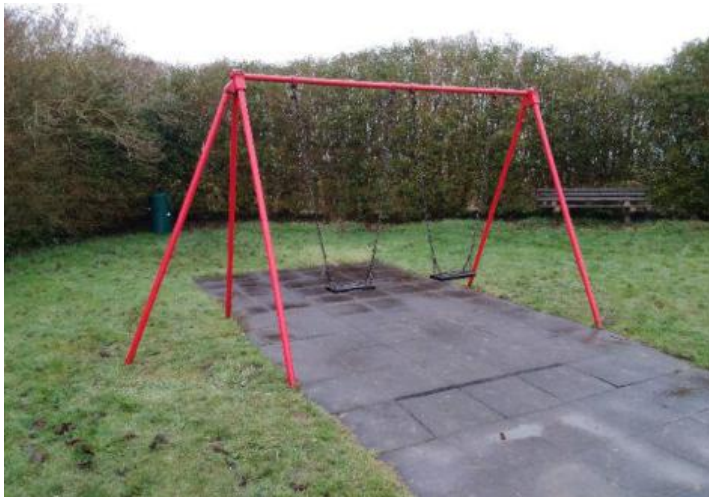
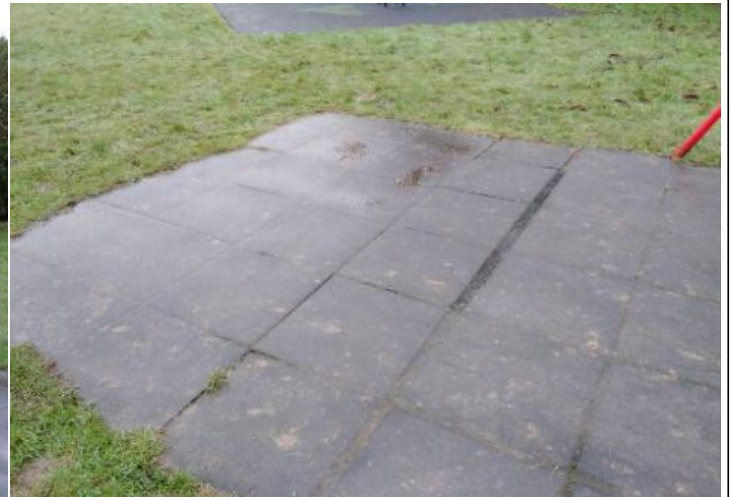
**Item:** Swings - 1 Bay 2 Seat (Flat)  
**Manufacturer:** G L Jones Playgrounds Ltd

**Finding:** The surface has subsided in some areas

**Action:** Monitor for any further deterioration and repair as required

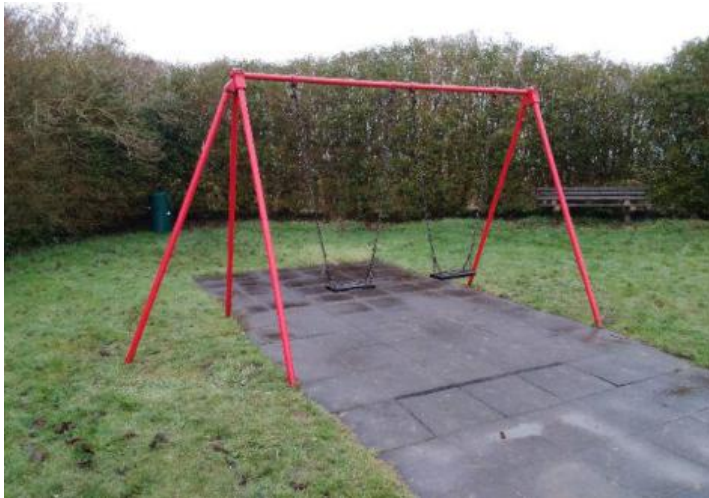
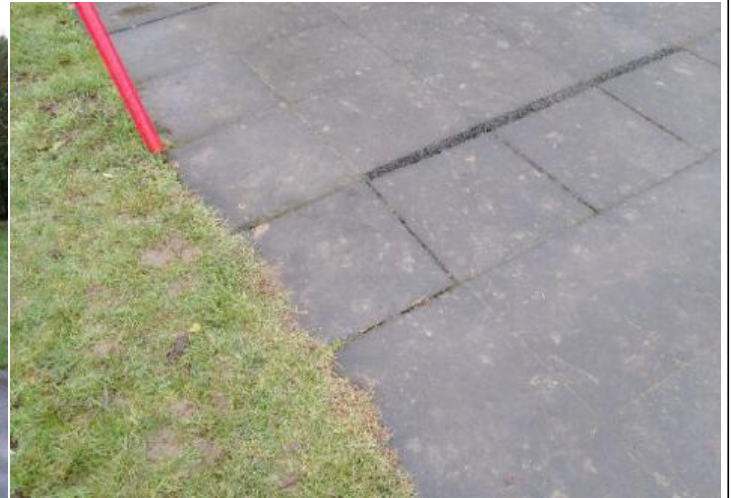
**Item:** Swings - 1 Bay 2 Seat (Flat)  
**Manufacturer:** G L Jones Playgrounds Ltd

**Finding:** There are gaps opening in between the tiles

**Action:** Monitor for any further deterioration and repair as required

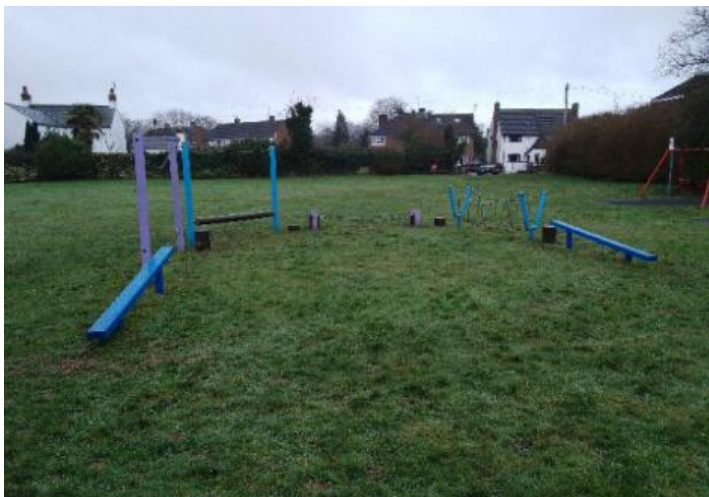
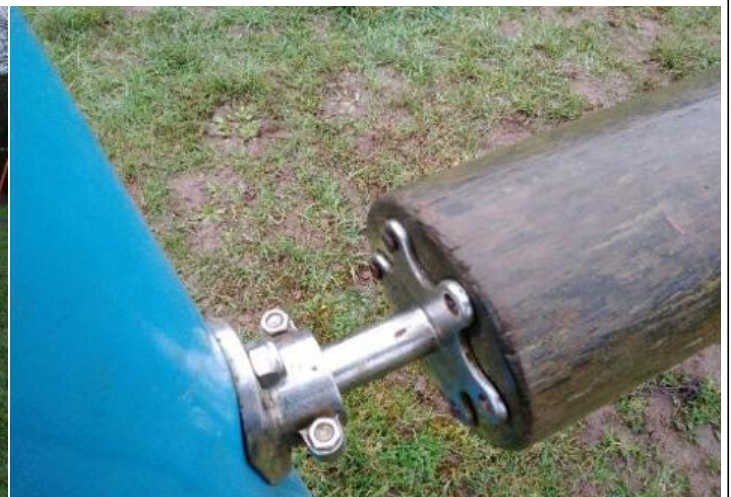
**Item:** Activity Equipment - Activity Trail  
**Manufacturer:** Not Identified

**Finding:** A number of fixing(s) have worked loose

**Action:** Secure all loose fixings

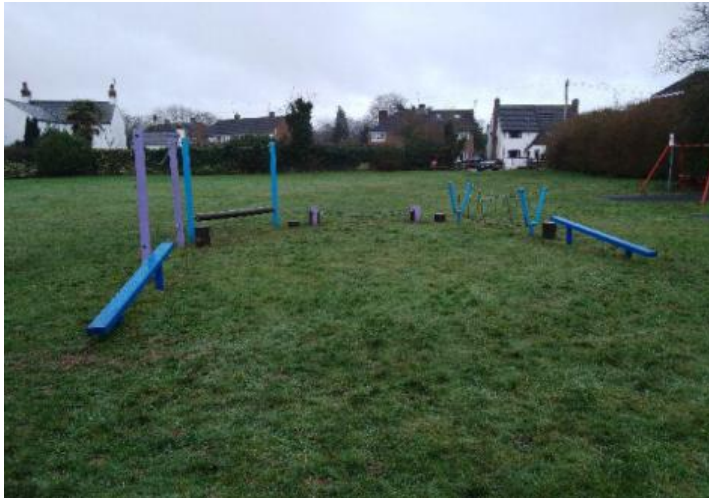
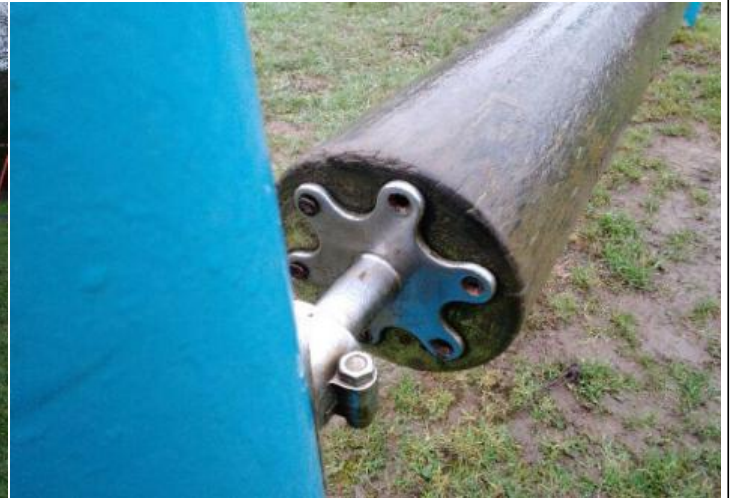
**Item:** Activity Equipment - Activity Trail  
**Manufacturer:** Not Identified

**Finding:** There is or are fixings missing on the item

**Action:** Replace all missing fixings

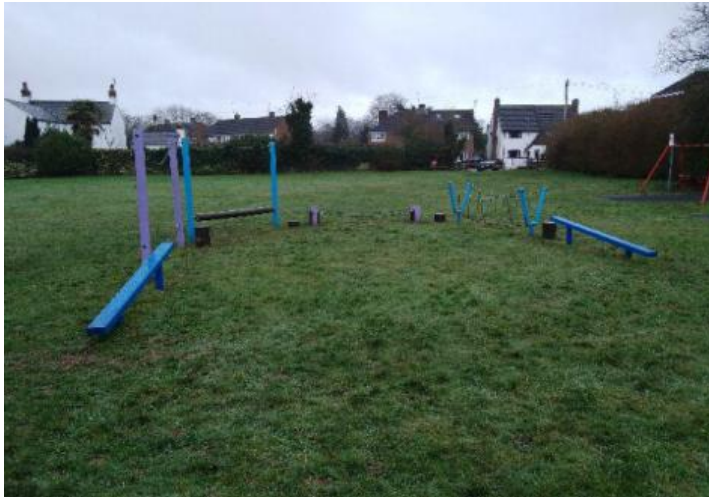
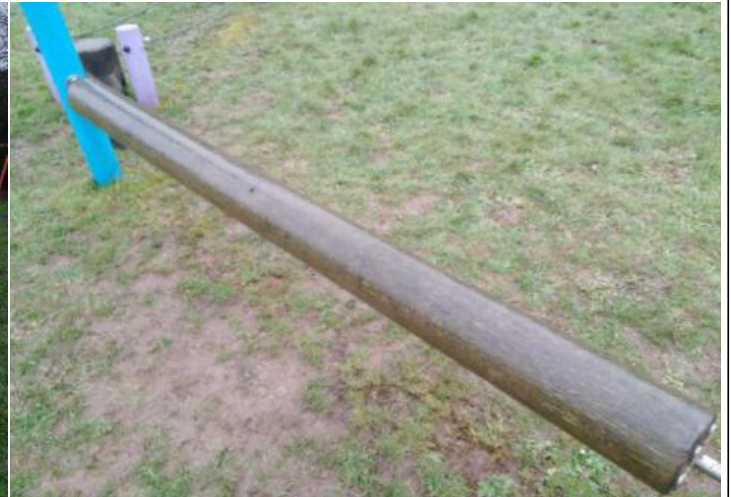
**Item:** Activity Equipment - Activity Trail  
**Manufacturer:** Not Identified

**Finding:** There is algae or moss on the surface of the equipment

**Action:** Clean and treat appropriately

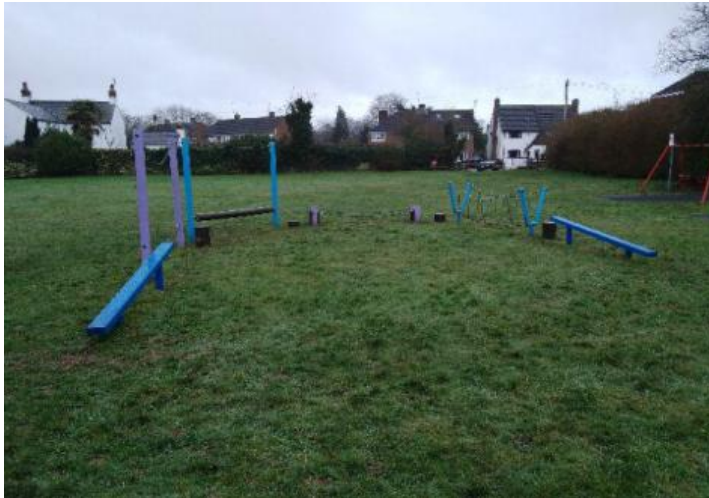
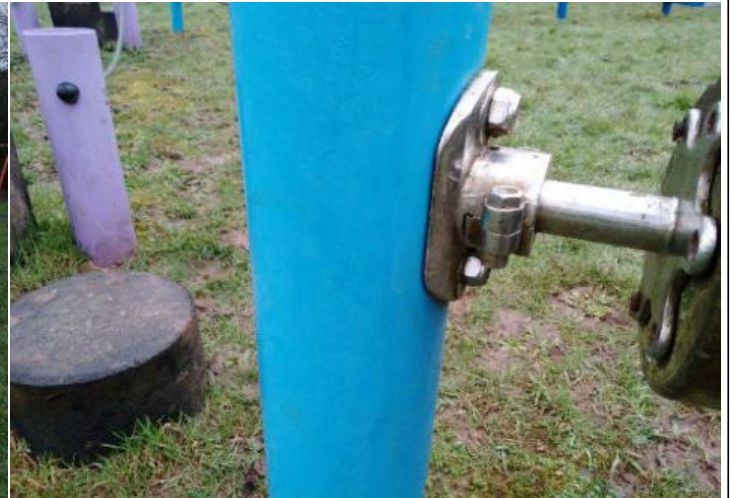
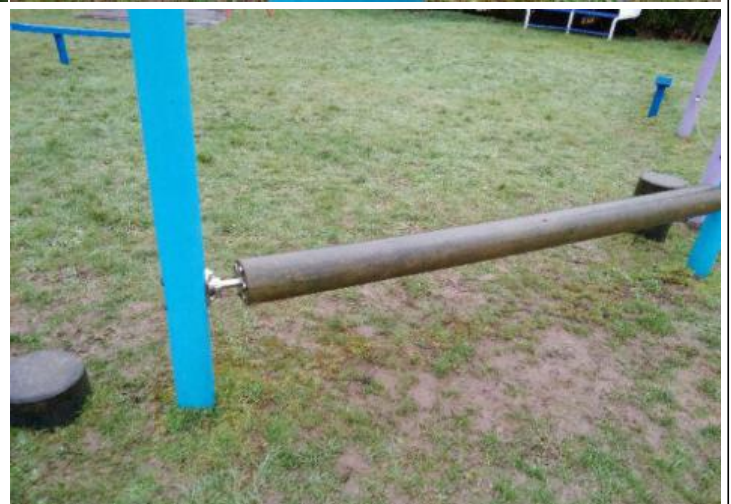
**Item:** Activity Equipment - Activity Trail  
**Manufacturer:** Not Identified

**Finding:** The rotating beam housing has been installed upside down

**Action:** Correct the positioning of the item

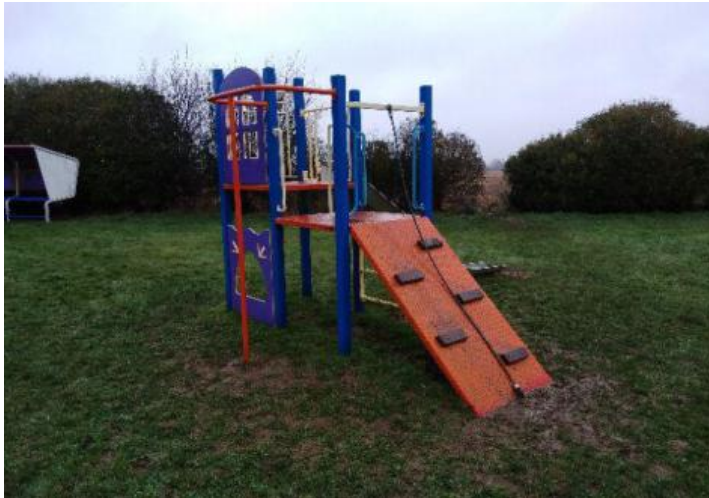
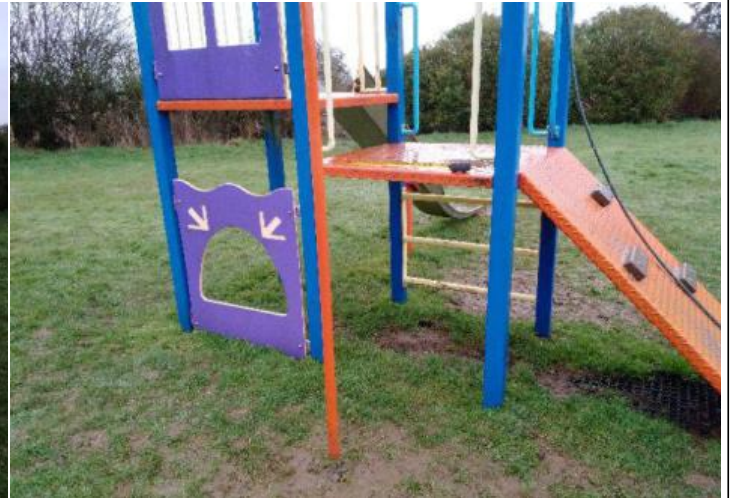
**Item:** Activity Equipment - Multi Play (Junior)  
**Manufacturer:** Not Identified

**Finding:** The unit is easily accessible and has an opening in the barrier to steep play elements in excess of 500mm in contravention of BS EN 1176 Part 1  
**Action:** Monitor - No remedial work recommended

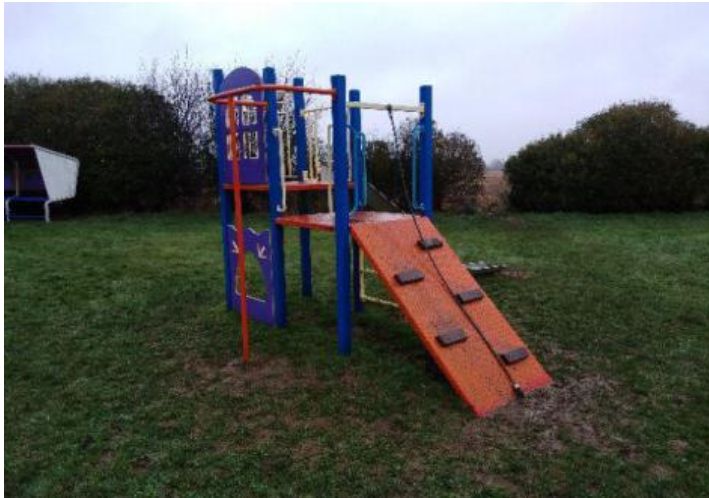
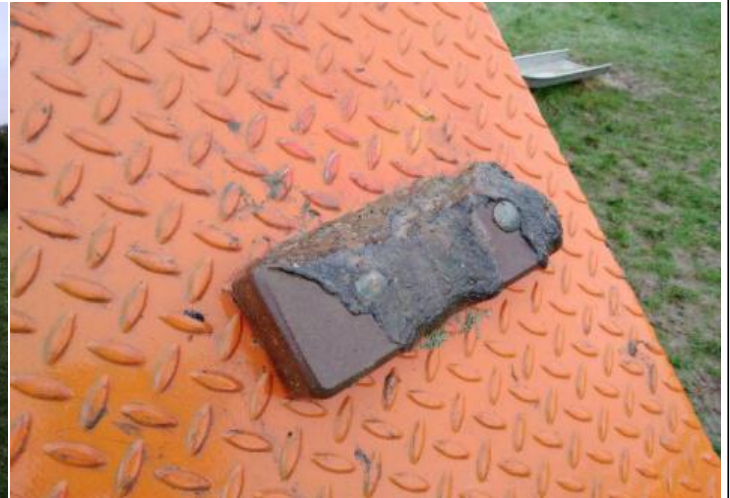
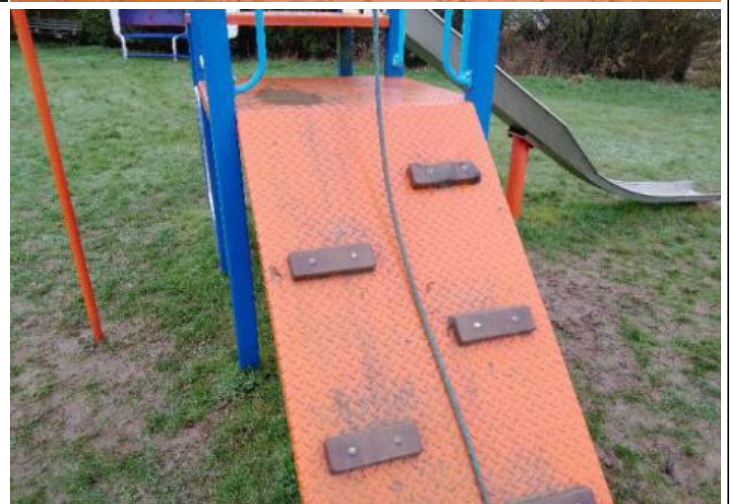
**Item:** Activity Equipment - Multi Play (Junior)  
**Manufacturer:** Not Identified

**Finding:** There is some evidence of fire damage to the item **Action:** Replace damaged component

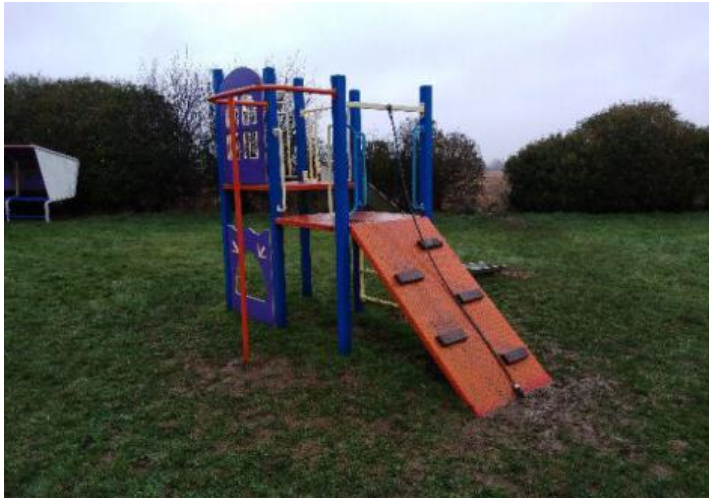
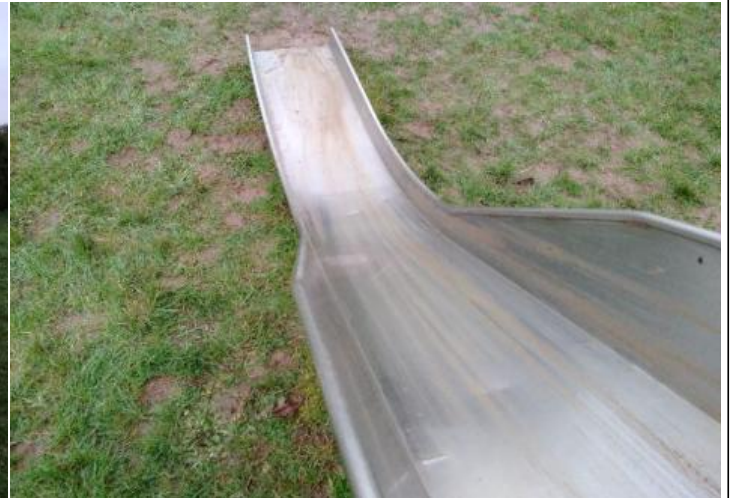
**Item:** Activity Equipment - Multi Play (Junior)  
**Manufacturer:** Not Identified

**Finding:** There are a number of dents in the slide surface

**Action:** Monitor for any further deterioration and repair as required
