Annual Inspection

St Albans City and District Council

Tyttenhanger Field Play Area

Inspection Ref: 1294384

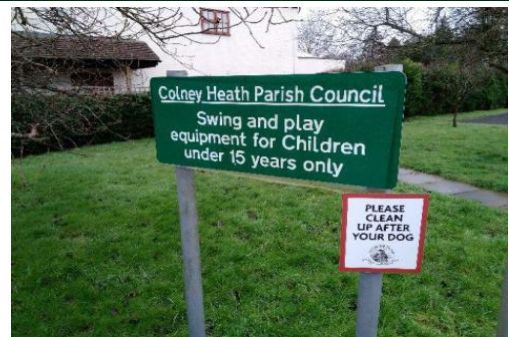
Item:	Sign
Manufacturer:	Owner/Operator
Surface Type:	Grass
Item Quantity:	1
Equipment Compliance:	N/A
Surface Area Compliance:	N/A
Total Findings:	2

Finding 1	Finding 2
There are post / end caps missing from the item - Replace missing post caps	It is recommended that signage, with information including the site address, contact information for maintenance issues and emergency contact details are provided for the facility - Provide in accordance with the recommendations

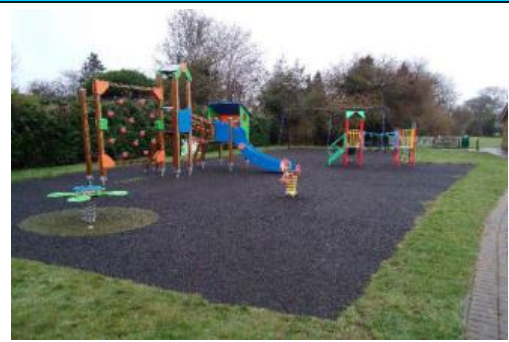
Item:	Site General
Manufacturer:	Owner/Operator
Surface Type:	N/A
Item Quantity:	1
Equipment Compliance:	N/A
Surface Area Compliance:	N/A
Total Findings:	1

Finding 1
This item is satisfactory - no work required -

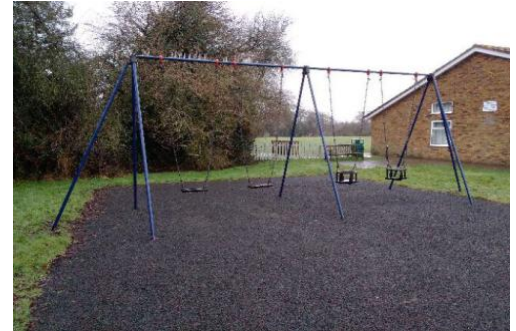
Item: 2 Bay 2 Flat 2 Cradle
Manufacturer: G L Jones Playgrounds Ltd
Surface Type: Bonded Rubber Mulch
Item Quantity: 1
Equipment Compliance: No
Surface Area Compliance: Yes

The seats are too close to the frame as defined in BS EN 1176 Part 2; this is a low risk failure and no remedial action is required - Monitor - No remedial work recommended

The chain openings are in excess of the 8.6mm as recommended by BS EN 1176 - Monitor - No remedial work recommended

There is some notable evidence of chain wear - Monitor for any further deterioration and replace when 40% worn

We do not recommend the installation of anti bird devices on equipment - Remove the device from the swing frame

The safety surface around the area is beginning to wear - Monitor for any further deterioration and repair as required

The surfacing around the item is damaged - Repair the damaged areas of surfacing

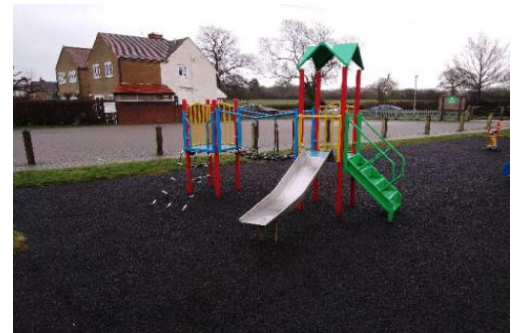
Item: Multi Play (Toddler)
Manufacturer: Safe & Sound
Surface Type: Bonded Rubber Mulch
Item Quantity: 1
Equipment Compliance: No
Surface Area Compliance: Yes

The height of the slide runout is in excess of 200mm and fails the requirements of BS EN 1176 Part 3 - Monitor - No remedial work recommended

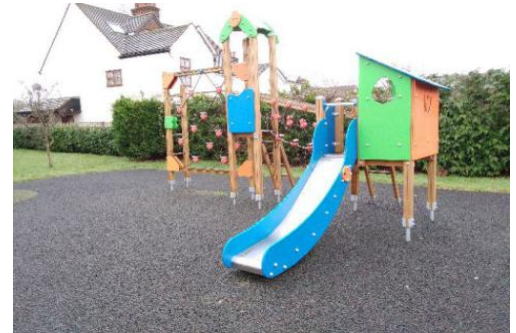
Item: Multi Play (Junior)
Manufacturer: Galopin
Surface Type: Bonded Rubber Mulch
Item Quantity: 1
Equipment Compliance: No
Surface Area Compliance: Yes

The item fails to meet the requirements of BS EN 1176 Part 1 4.2.7.2 head and neck entrapment in the barriers and/or steps - Monitor - No remedial work recommended

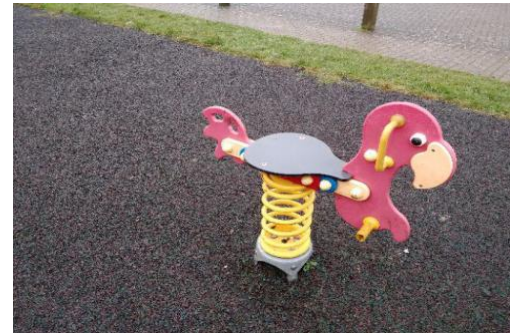
Item: Spring Toucan
Manufacturer: Fahr Industries
Surface Type: Bonded Rubber Mulch
Item Quantity: 1
Equipment Compliance: No
Surface Area Compliance: Yes

The end caps are missing on the Handgrips/Footrests - Replace missing end caps

The end of handgrips and/or footrests have a cross section of less than 15cm² and fail to meet the requirements of BS EN 1176 Part 6 - Monitor - No remedial work recommended

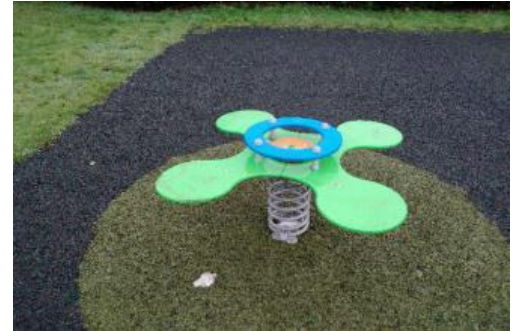
Item: Four Way Springer
Manufacturer: Galopin
Surface Type: Bonded Rubber Mulch
Item Quantity: 1
Equipment Compliance: Yes
Surface Area Compliance: Yes

This item is satisfactory - no work required -

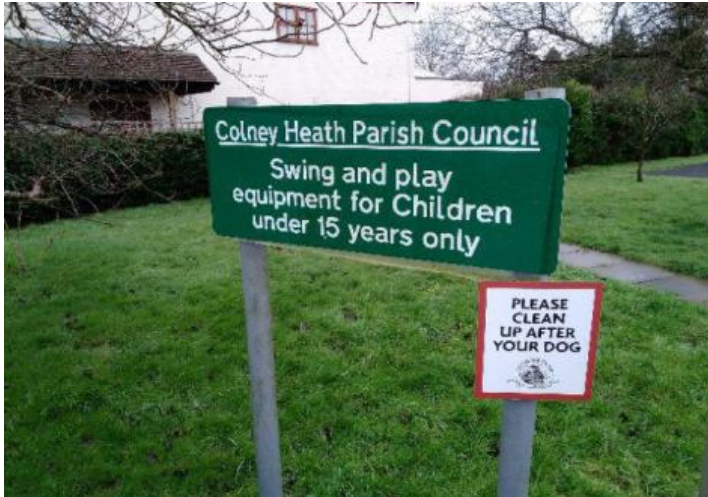
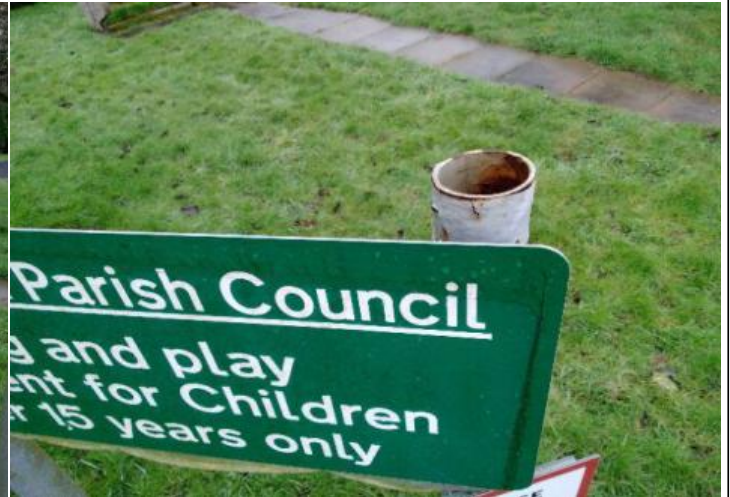
Item: Ancillary Items - Sign
Manufacturer: Owner/Operator

Finding: There are post / end caps missing from the item

Action: Replace missing post caps

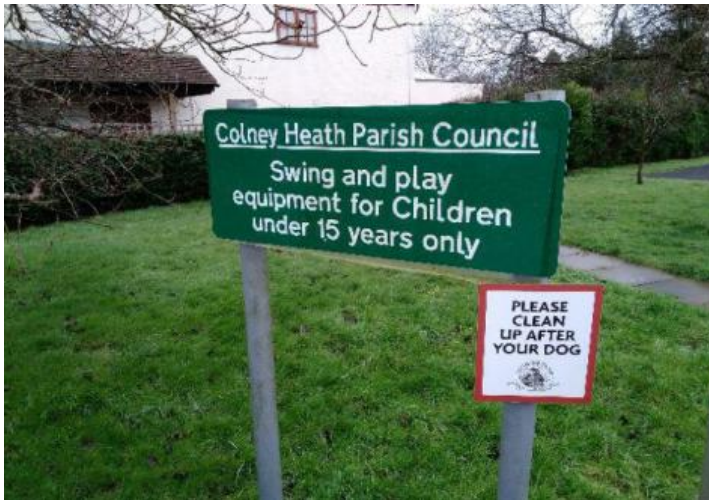
Item: Ancillary Items - Sign
Manufacturer: Owner/Operator

Finding: It is recommended that signage, with information including the site address, contact information for maintenance issues and emergency contact details are provided for the facility

Action: Provide in accordance with the recommendations

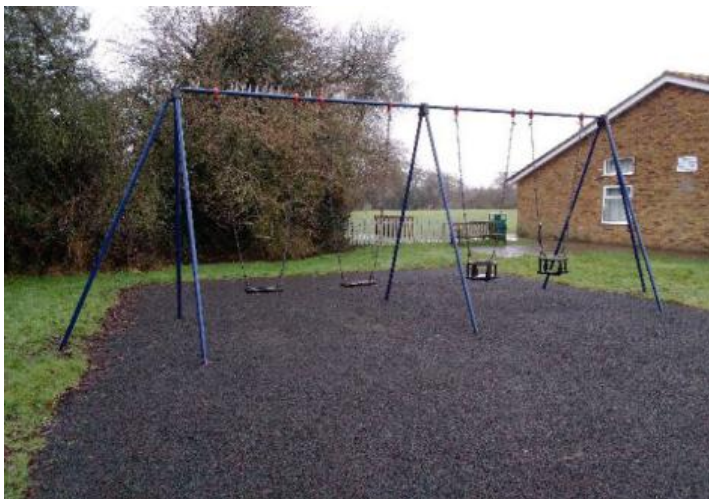
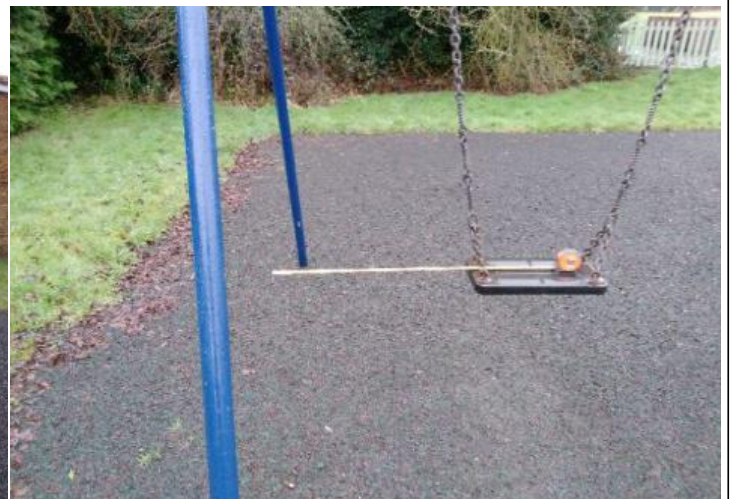
Item: Swings - 2 Bay 2 Flat 2 Cradle
Manufacturer: G L Jones Playgrounds Ltd

Finding: The seats are too close to the frame as defined in BS EN 1176 Part 2; this is a low risk failure and no remedial action is required

Action: Monitor - No remedial work recommended

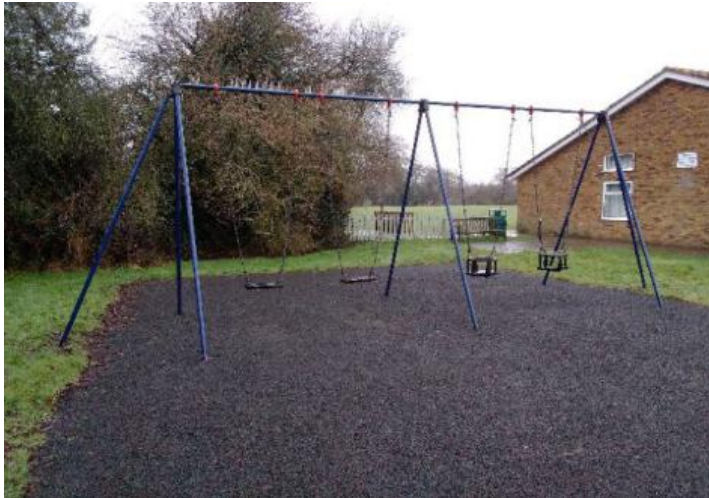
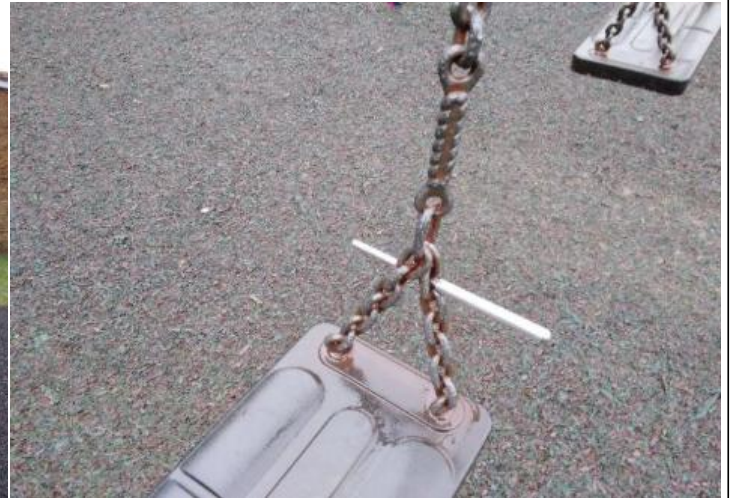
Item: Swings - 2 Bay 2 Flat 2 Cradle
Manufacturer: G L Jones Playgrounds Ltd

Finding: The chain openings are in excess of the 8.6mm as recommended by BS EN 1176
Action: Monitor - No remedial work recommended

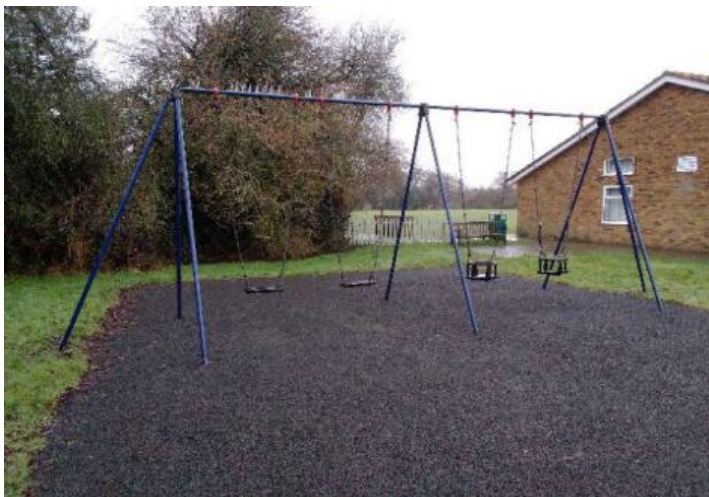
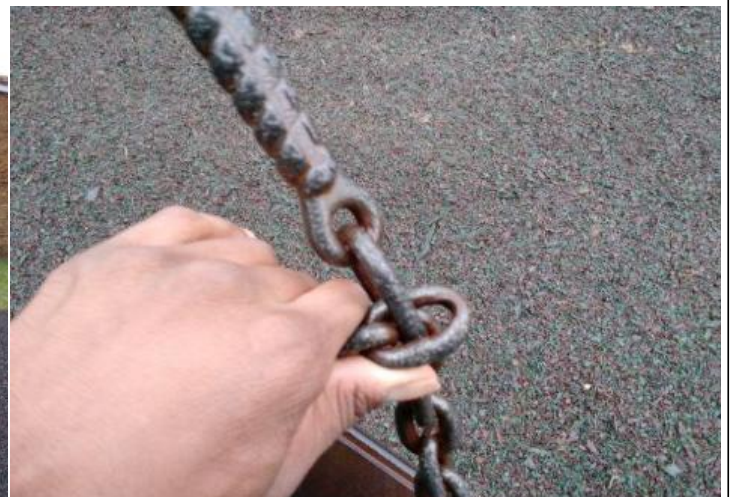
Item: Swings - 2 Bay 2 Flat 2 Cradle
Manufacturer: G L Jones Playgrounds Ltd

Finding: There is some notable evidence of chain wear
Action: Monitor for any further deterioration and replace when 40% worn

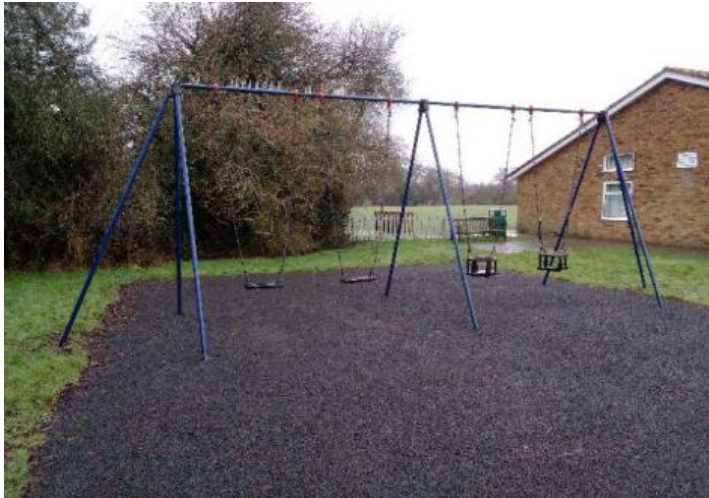
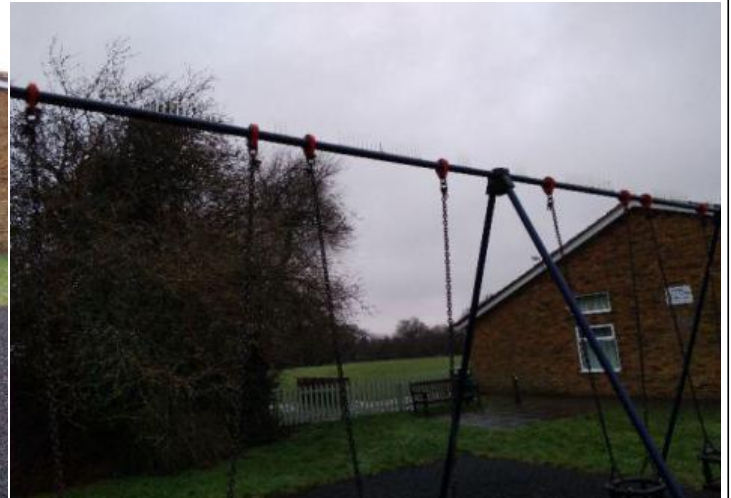
Item: Swings - 2 Bay 2 Flat 2 Cradle
Manufacturer: G L Jones Playgrounds Ltd

Finding: We do not recommend the installation of anti bird devices on equipment

Action: Remove the device from the swing frame

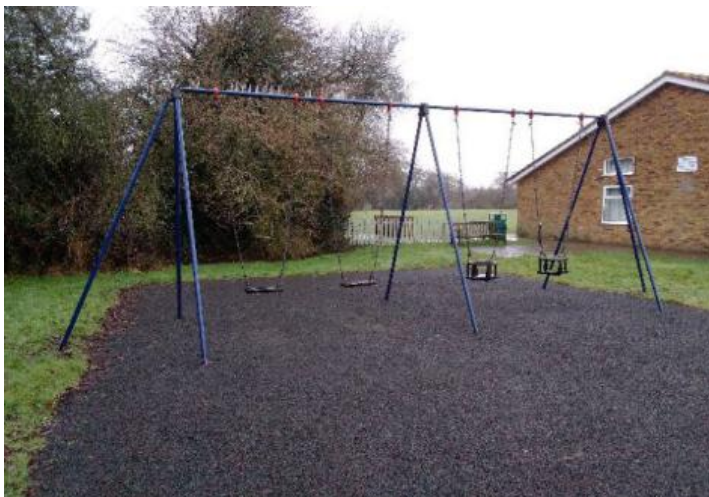
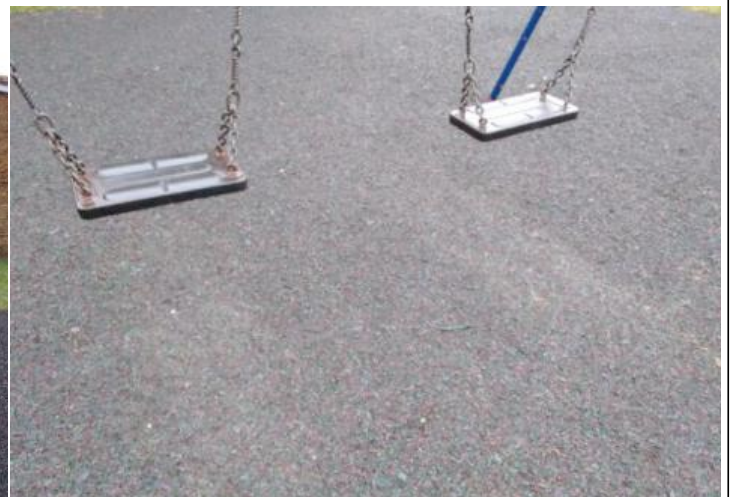
Item: Swings - 2 Bay 2 Flat 2 Cradle
Manufacturer: G L Jones Playgrounds Ltd

Finding: The safety surface around the area is beginning to wear

Action: Monitor for any further deterioration and repair as required

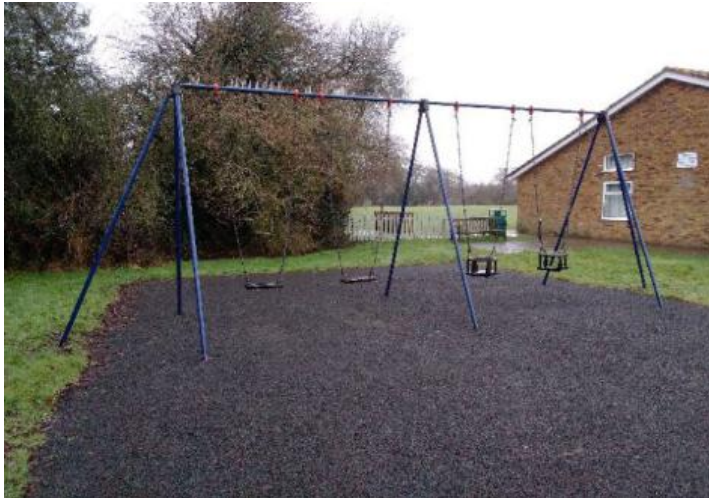
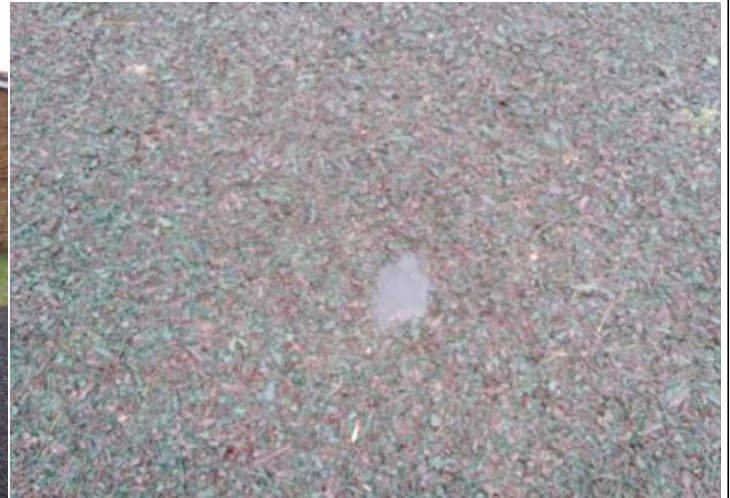
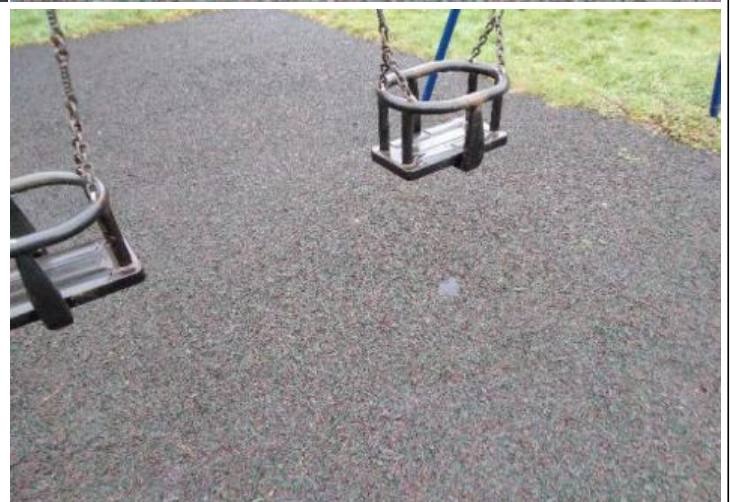
Item: Swings - 2 Bay 2 Flat 2 Cradle
Manufacturer: G L Jones Playgrounds Ltd

Finding: The surfacing around the item is damaged

Action: Repair the damaged areas of surfacing

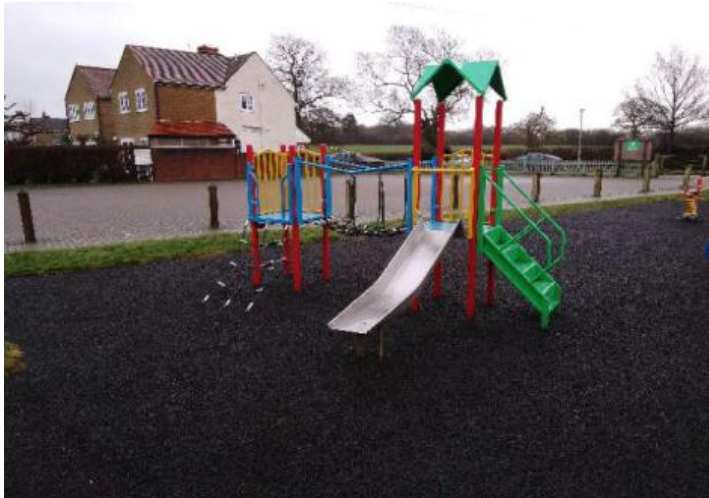
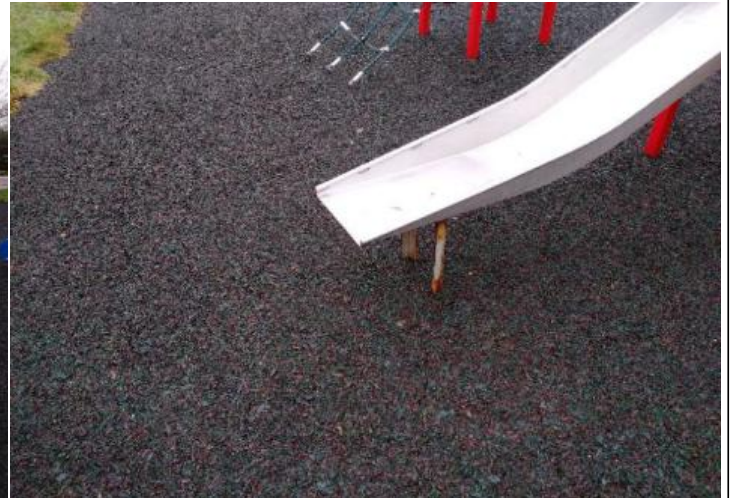
Item: Activity Equipment - Multi Play (Toddler)
Manufacturer: Safe & Sound

Finding: The height of the slide runout is in excess of 200mm and fails the requirements of BS EN 1176 Part 3

Action: Monitor - No remedial work recommended

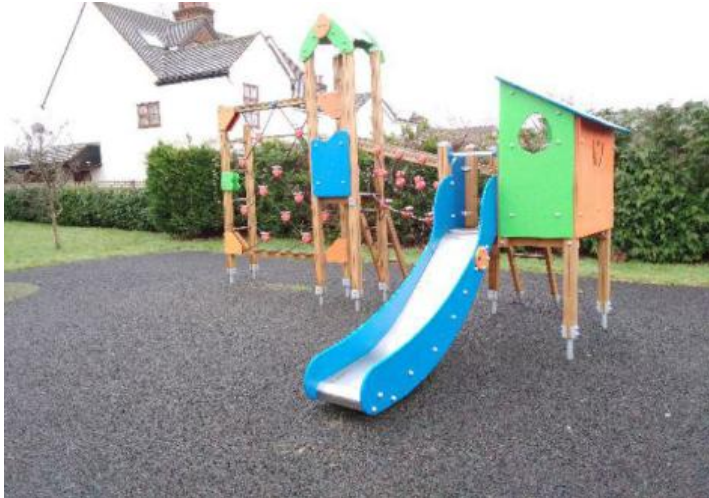
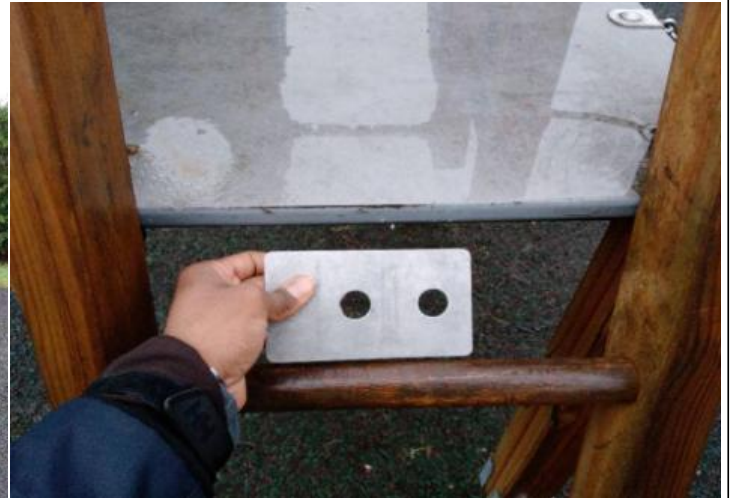
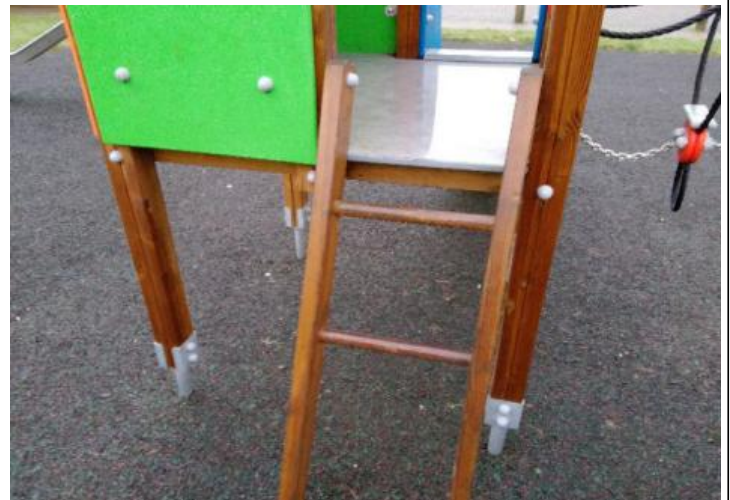
Item: Activity Equipment - Multi Play (Junior)
Manufacturer: Galopin

Finding: The item fails to meet the requirements of BS EN 1176 Part 1 4.2.7.2 head and neck entrapment in the barriers and/or steps

Action: Monitor - No remedial work recommended

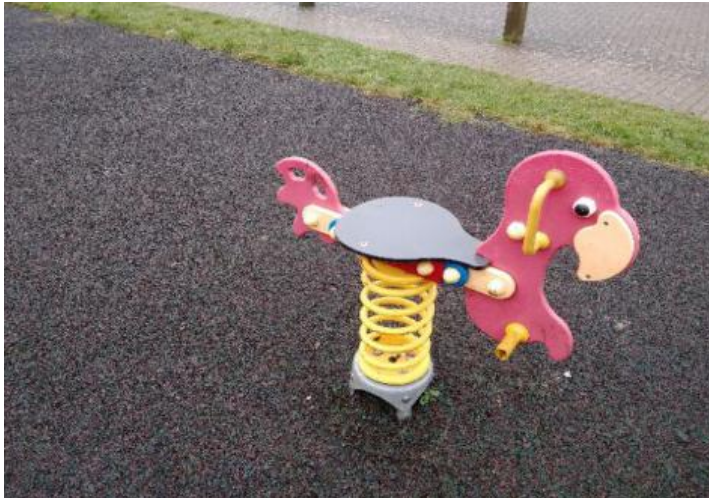
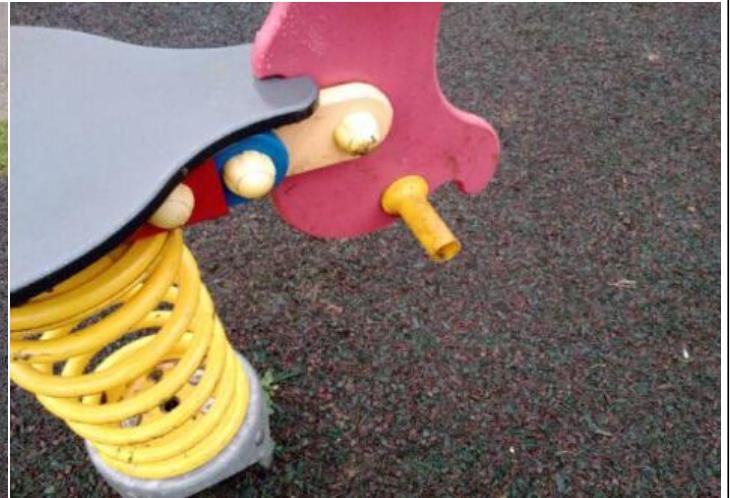
Item: Rocking Equipment - Spring Toucan
Manufacturer: Fahr Industries

Finding: The end caps are missing on the Handgrips/Footrests

Action: Replace missing end caps

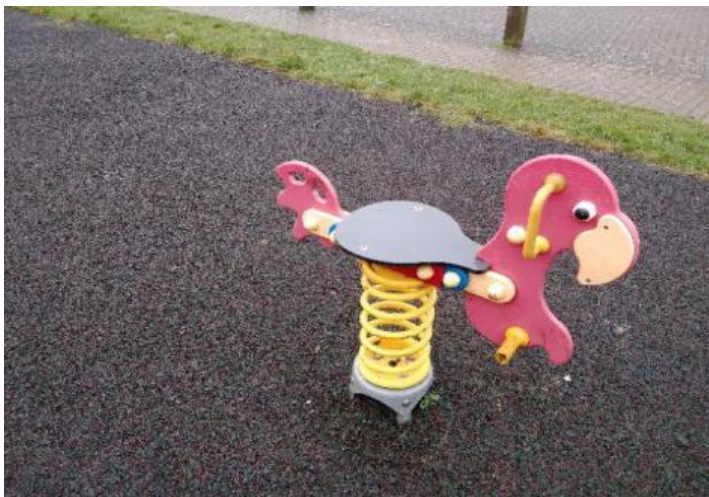
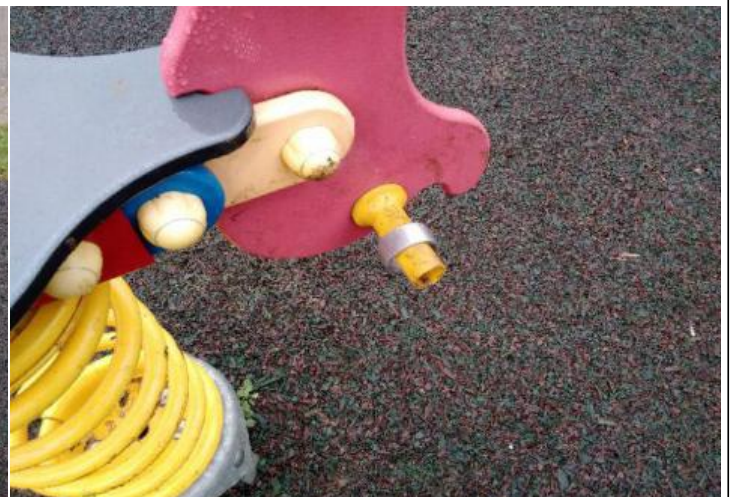
Item: Rocking Equipment - Spring Toucan
Manufacturer: Fahr Industries

Finding: The end of handgrips and/or footrests have a cross section of less than 15cm² and fail to meet the requirements of BS EN 1176 Part 6

Action: Monitor - No remedial work recommended
