the **play inspection** company

Annual Inspection

High Street Recreation Ground

Inspection Ref: 1294386

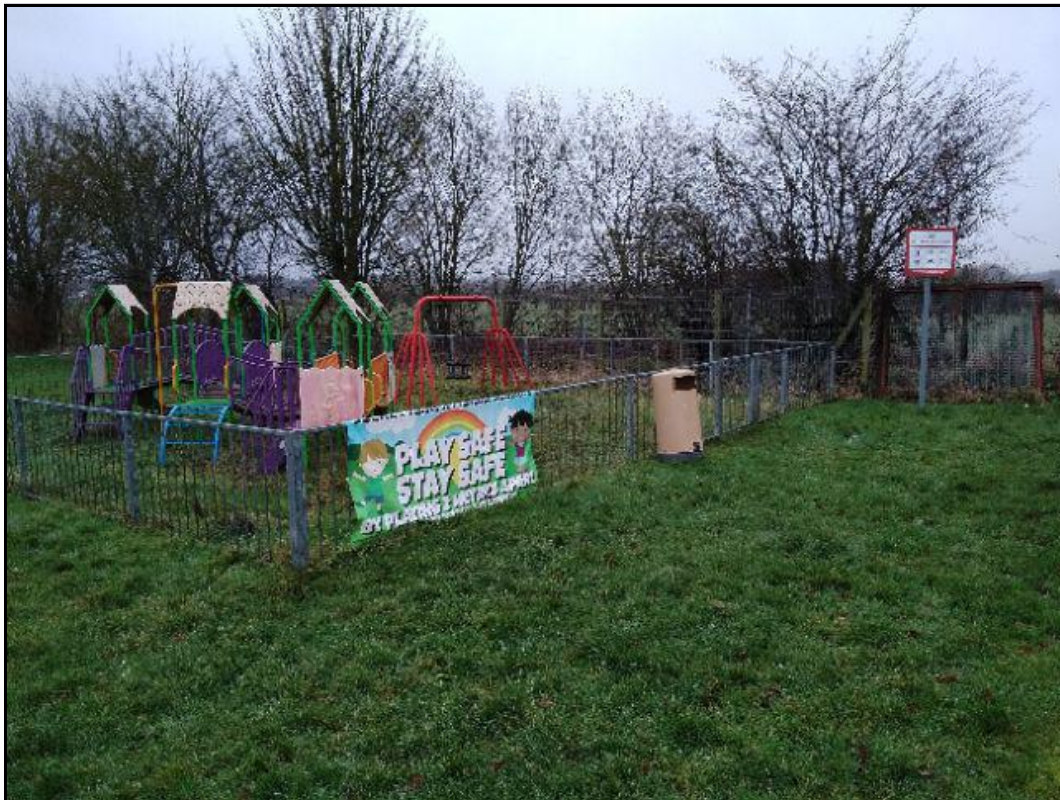
Risk Assessment: 8 Low Risk

The site is located in an area of public open space and is not directly overlooked by any properties in the local community.
